Seismic performance of precast industrial facilities following major earthquakes in the Italian territory

On the basis of detailed field observations on a relevant number of buildings, collected just after the earthquakes, seven representative industrial facilities are examined to outline the main vulnerabilities of one-storey precast concrete structures not designed and detailed for seismic loads.

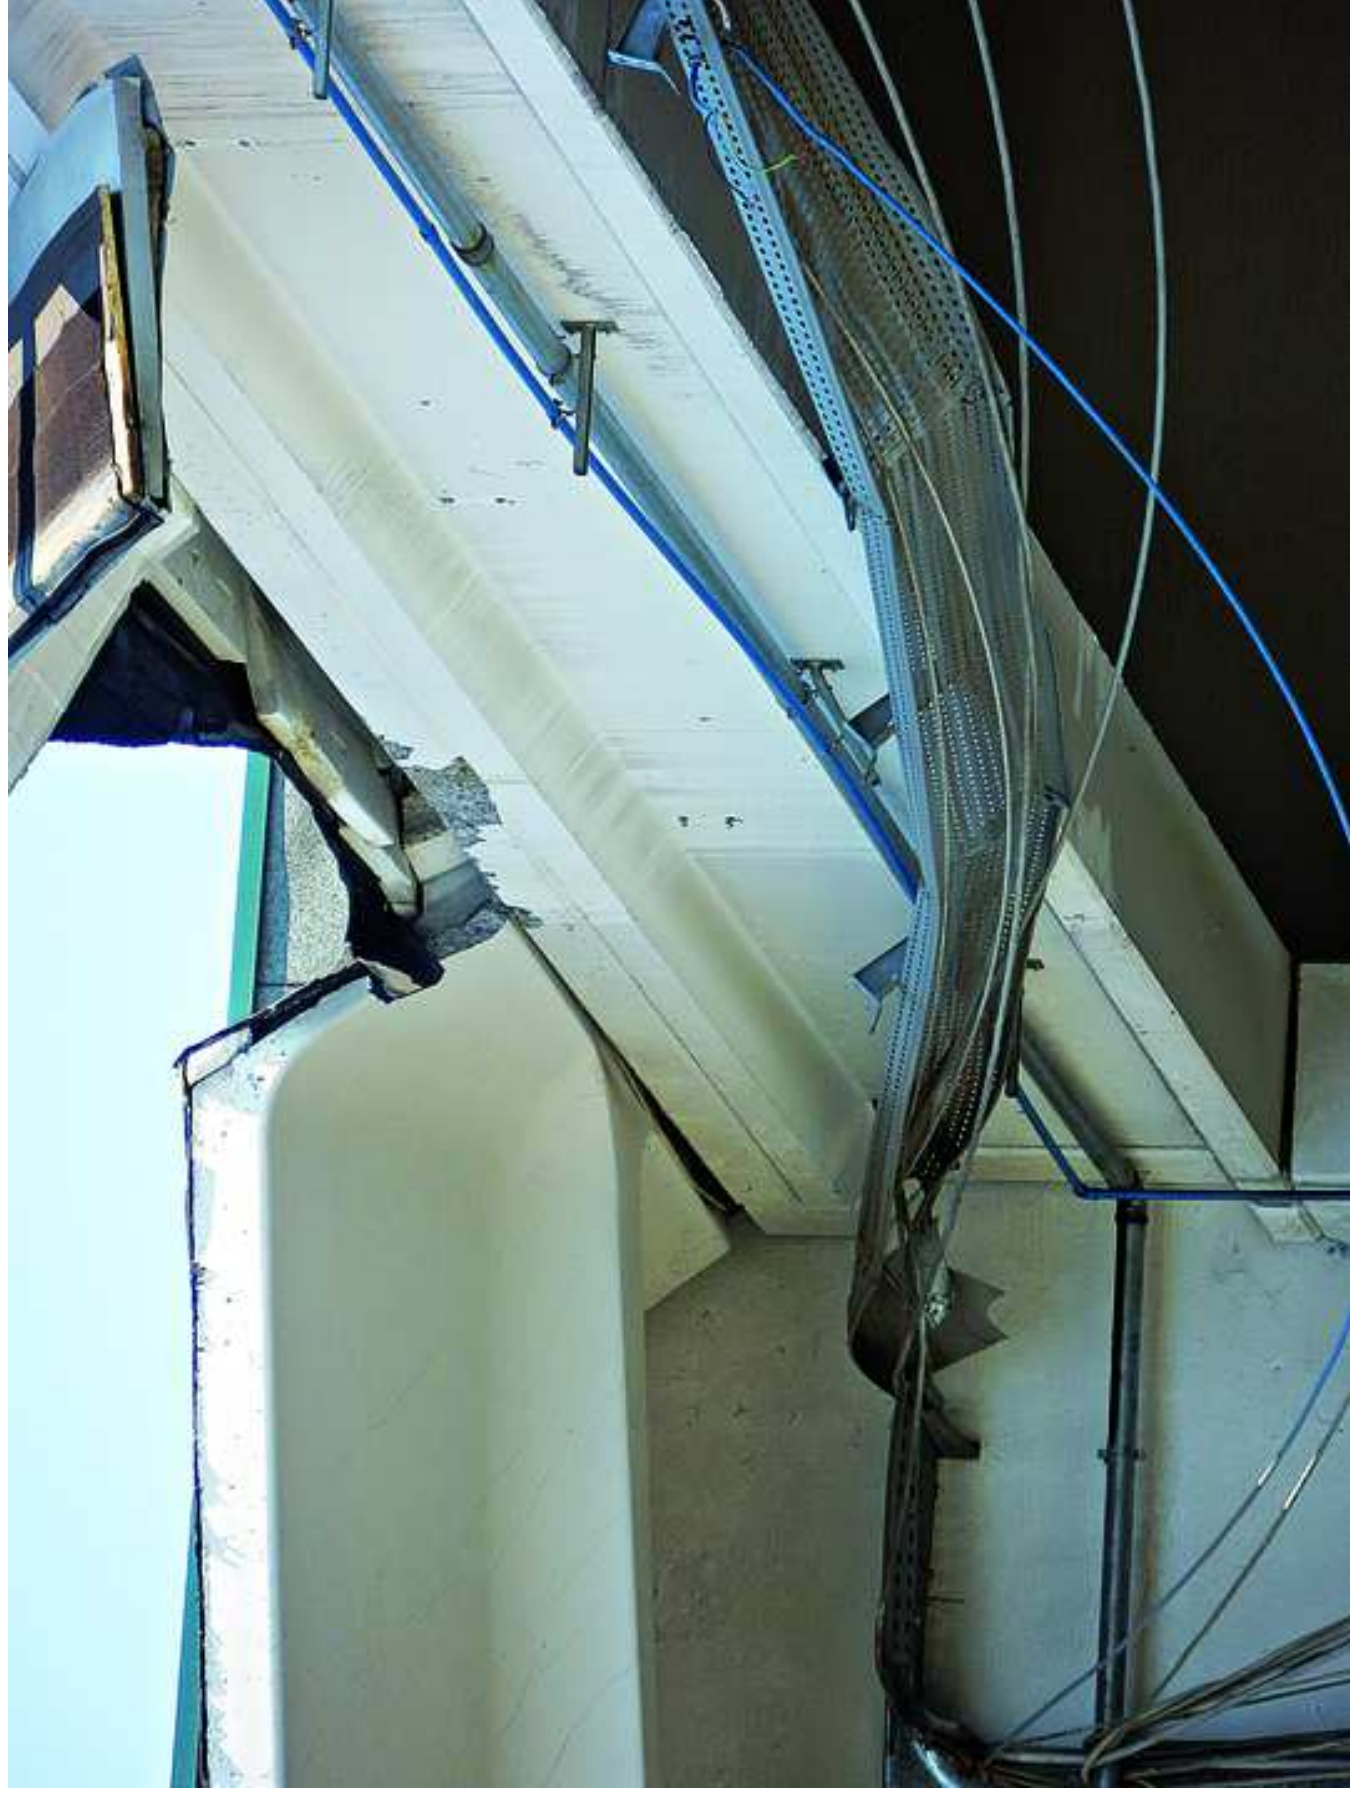
Figure 5

As mentioned before, the most severe damage observed during the Emilia earthquakes is associated to the structural element loss of support and consequent falling, since the beam-to-column and roof-to-beam connections lacked mechanical devices as a seismic load transfer mechanism. Such type of collapse affected more significantly structures belonging to category A. Fig. 5 shows the loss of support of roof elements from the supporting beam, while Fig. 6 depicts the failure mode of a

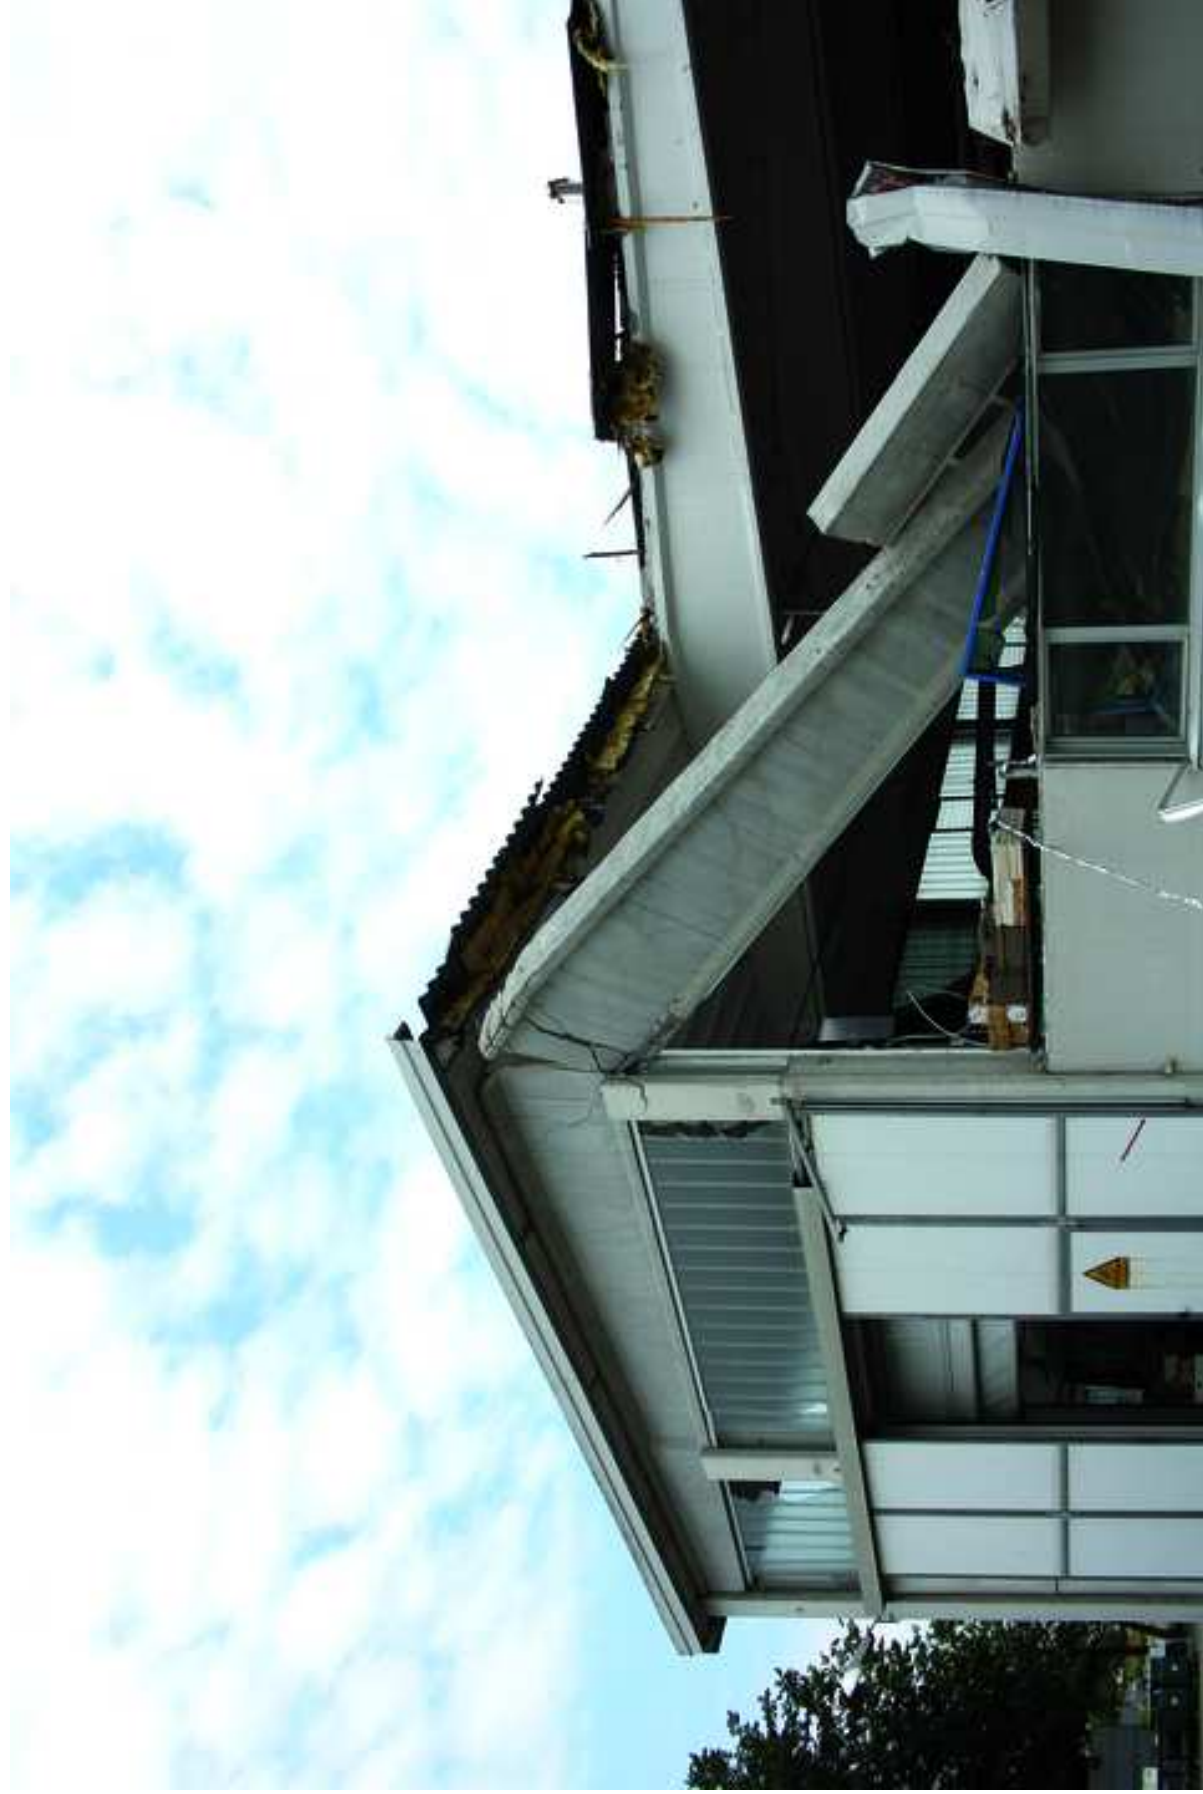
Figure 6

precast tapered I-beam due to its interaction with a column placed at the mid-span of the facade portal frame: designed as an element simply supported at its ends, the beam lost one of its supports during the earthquake and failed in flexure at mid-span, in accordance with a cantilevered static scheme not considered during design.

Fig. 6. Precast tapered I-beam failure due to the loss of support

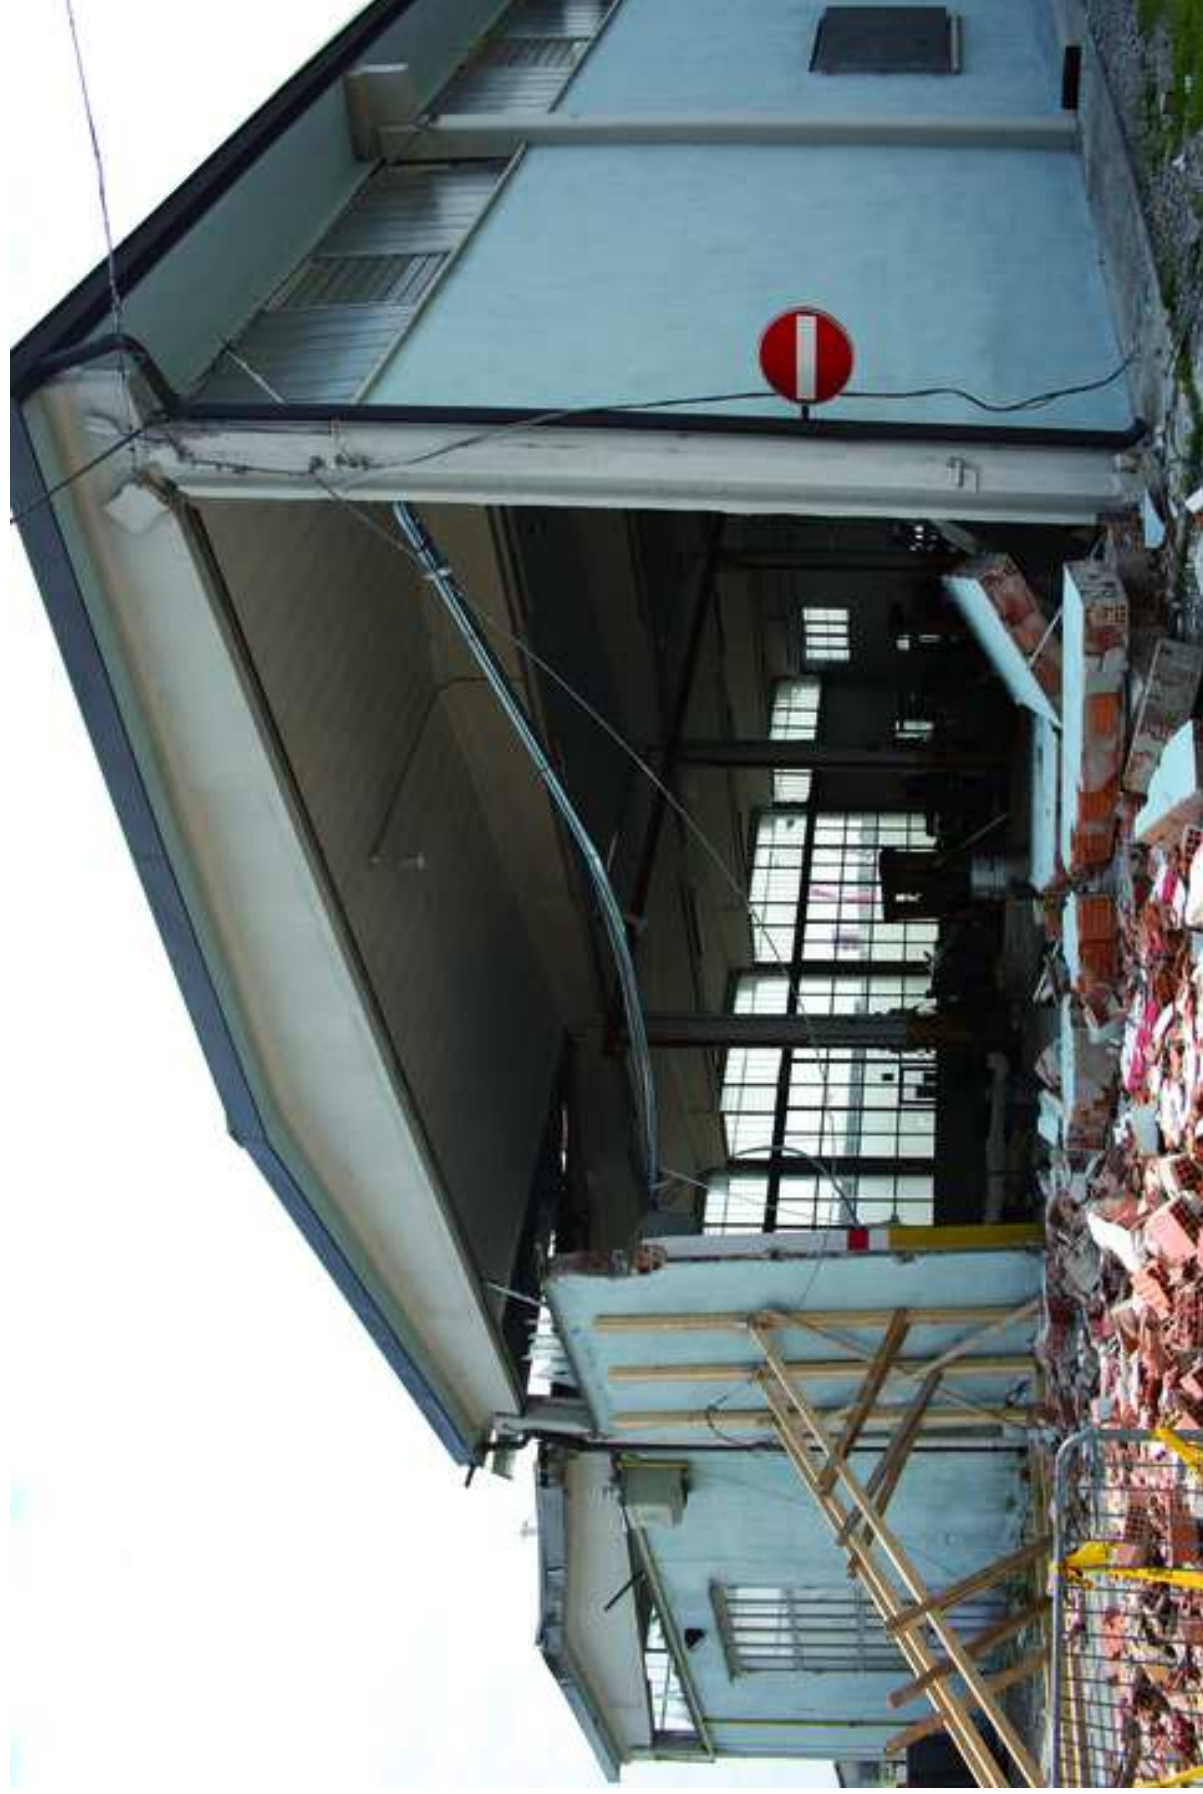
Figure 9

Another frequent failure typology observed is the collapse of the cladding panels, consisting both of brick masonry and precast RC elements. For what concerns the former, traditionally used in buildings of category A, the incipient collapse was observed to be associated with the high out-of-plane slenderness, as no lateral restraint was provided in correspondence to columns and RC spandrels (Fig. 9).

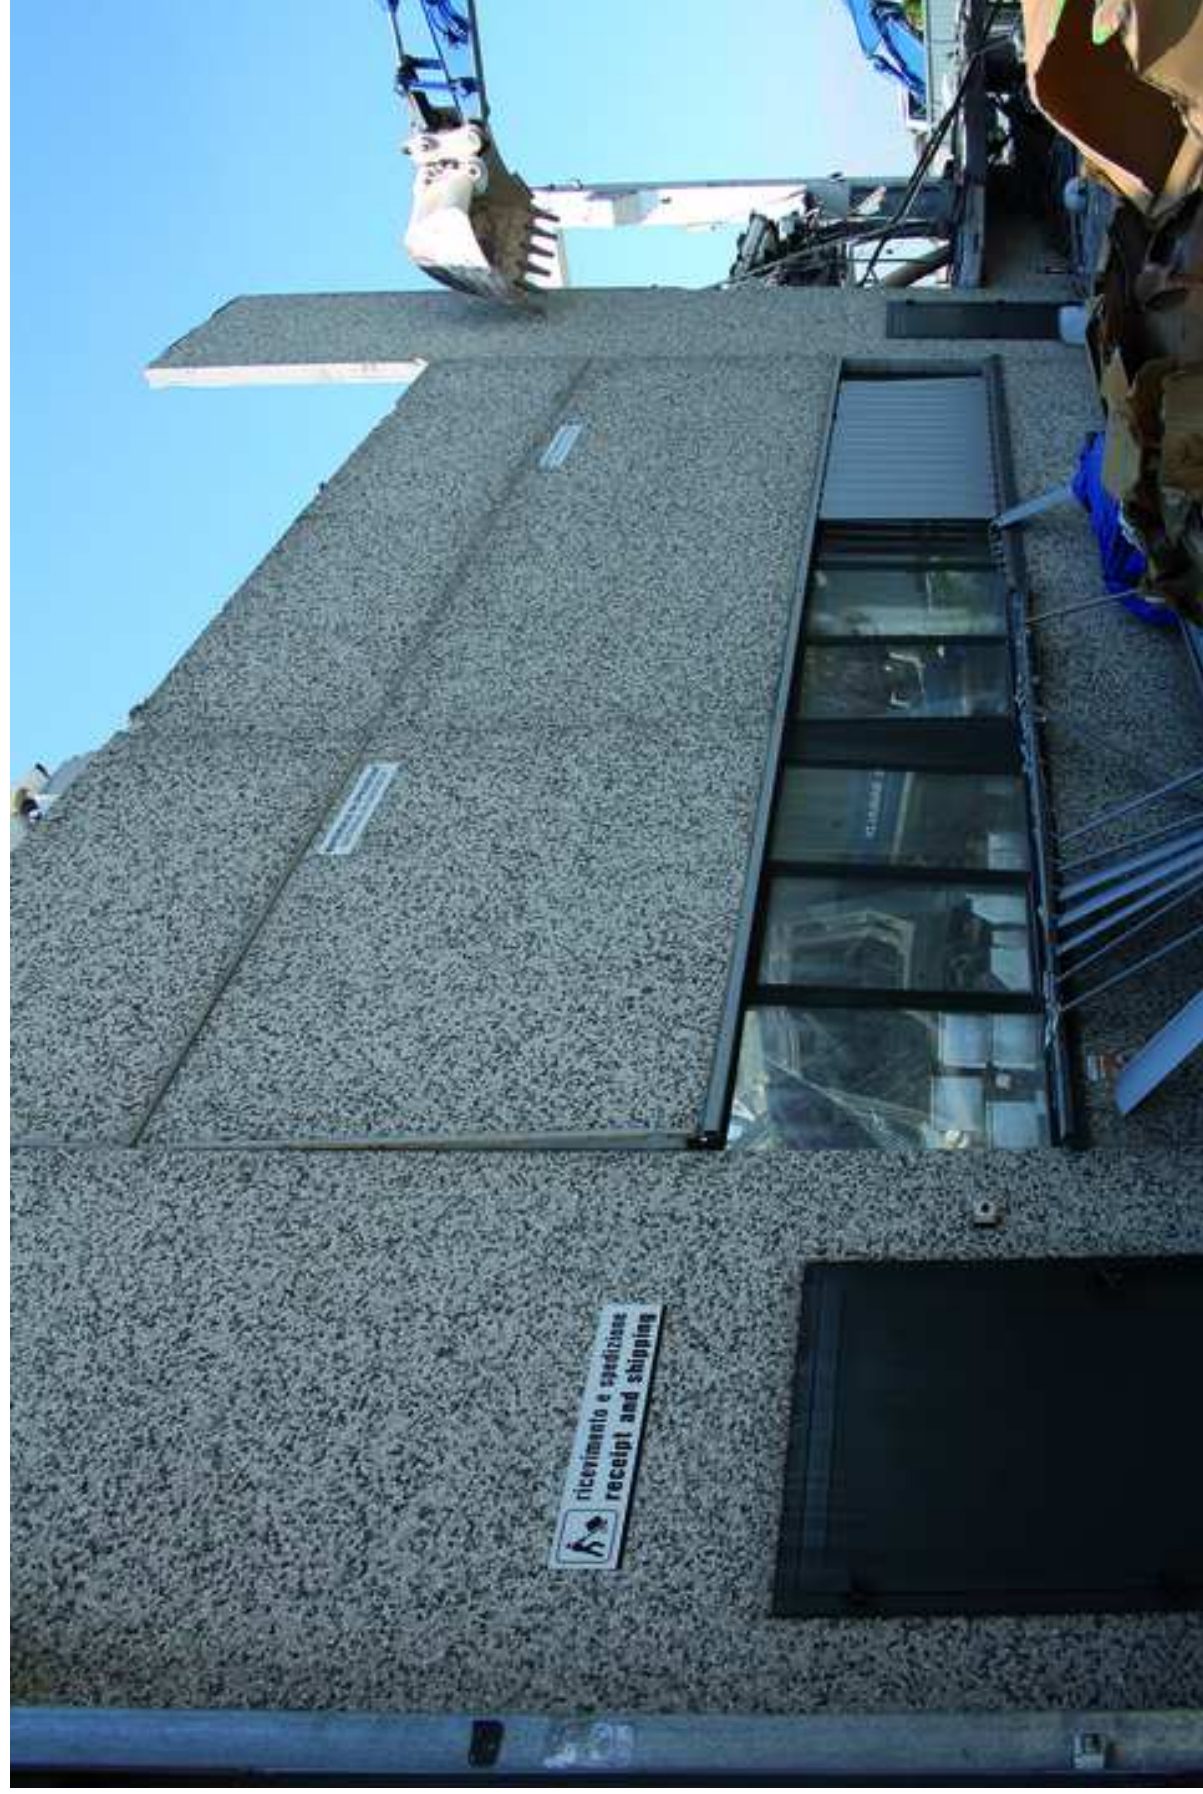
Figure 10

Conversely, in structures of category B, the observed falling of horizontal (Fig. 10) and vertical (Fig. 11) RC precast cladding panels was clearly related to failure in the mechanical connections, typically anchor channels and C-shape or L-shape steel profiles, to the supporting columns and/or beams. In fact, these devices were designed to sustain mainly vertical gravity loads and to avoid the panel overturning as a consequence of low out of plane horizontal actions, such as wind loads. During an earthquake these connections need to accommodate high relative displacements and rotations, being the displacement and rotation demand concentrated at the connection level owing its lower stiffness compared to the connected precast elements.

Fig. 10. Horizontal precast cladding panels collapse due to connection failure

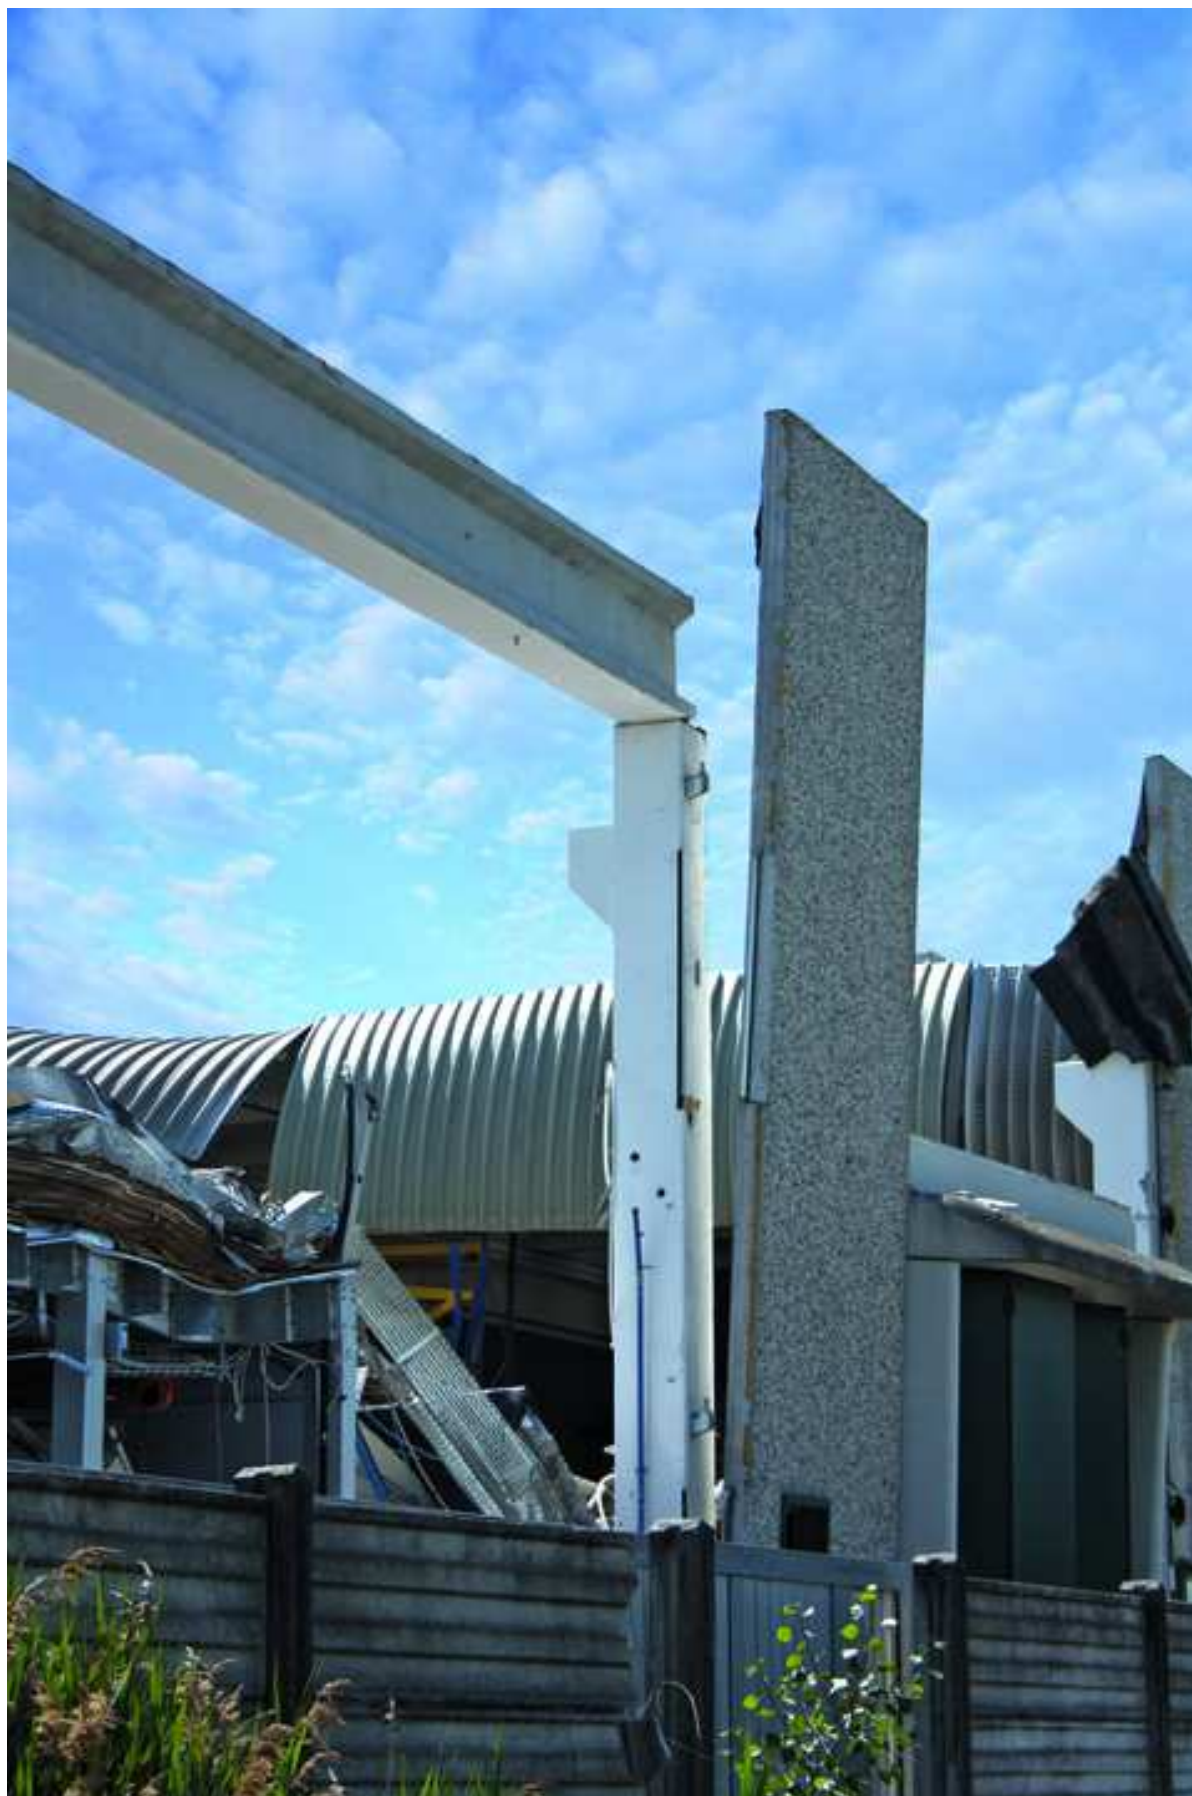
Figure 11
[Click here to download high resolution image](#)

Fig. 11. Vertical precast cladding panels collapse due to connection failure

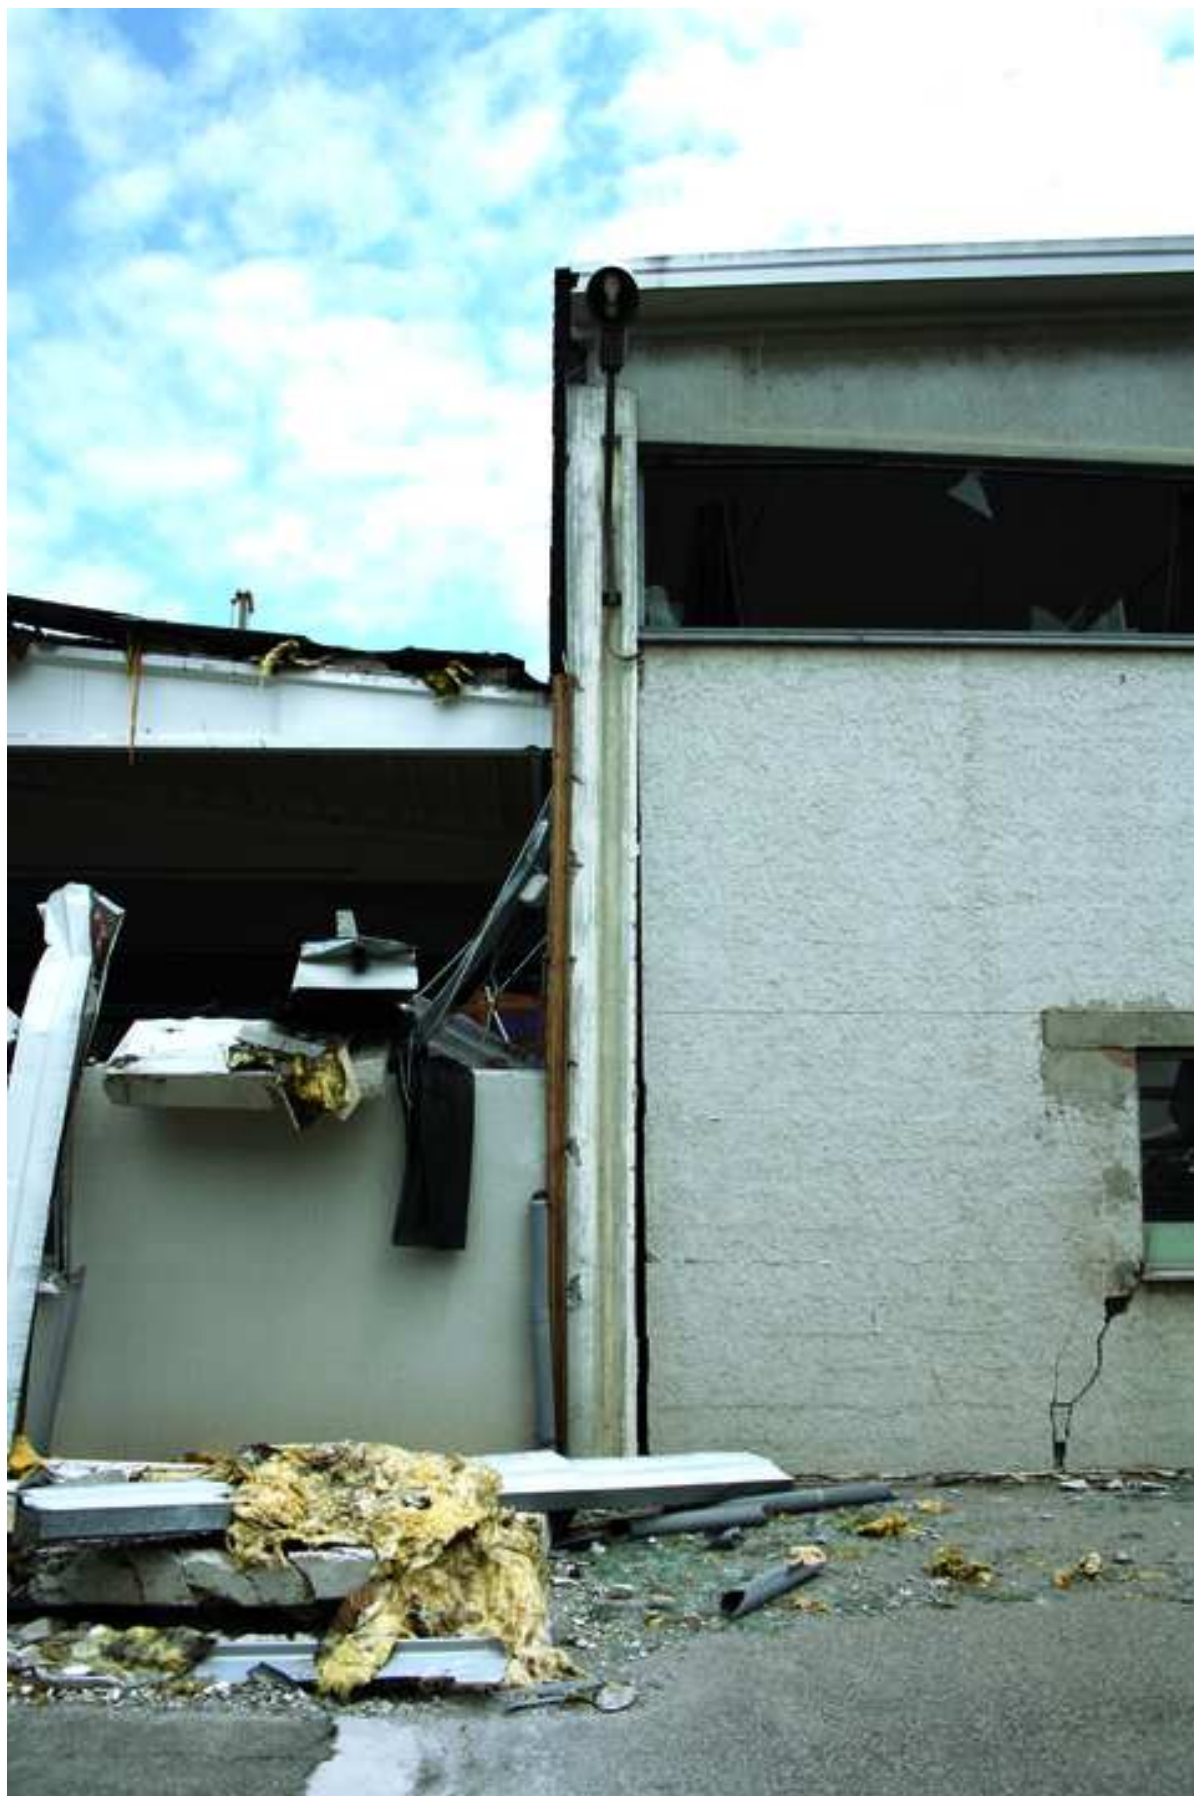
Figure 12
[Click here to download high resolution image](#)

Other damaged elements observed in Emilia are the columns. As depicted in Fig. 12 and 13, some columns lost their verticality due to permanent relative displacements and rotations experienced at

the foundation level, where socket foundations not designed for seismic loading were provided without additional interconnecting tie beams.

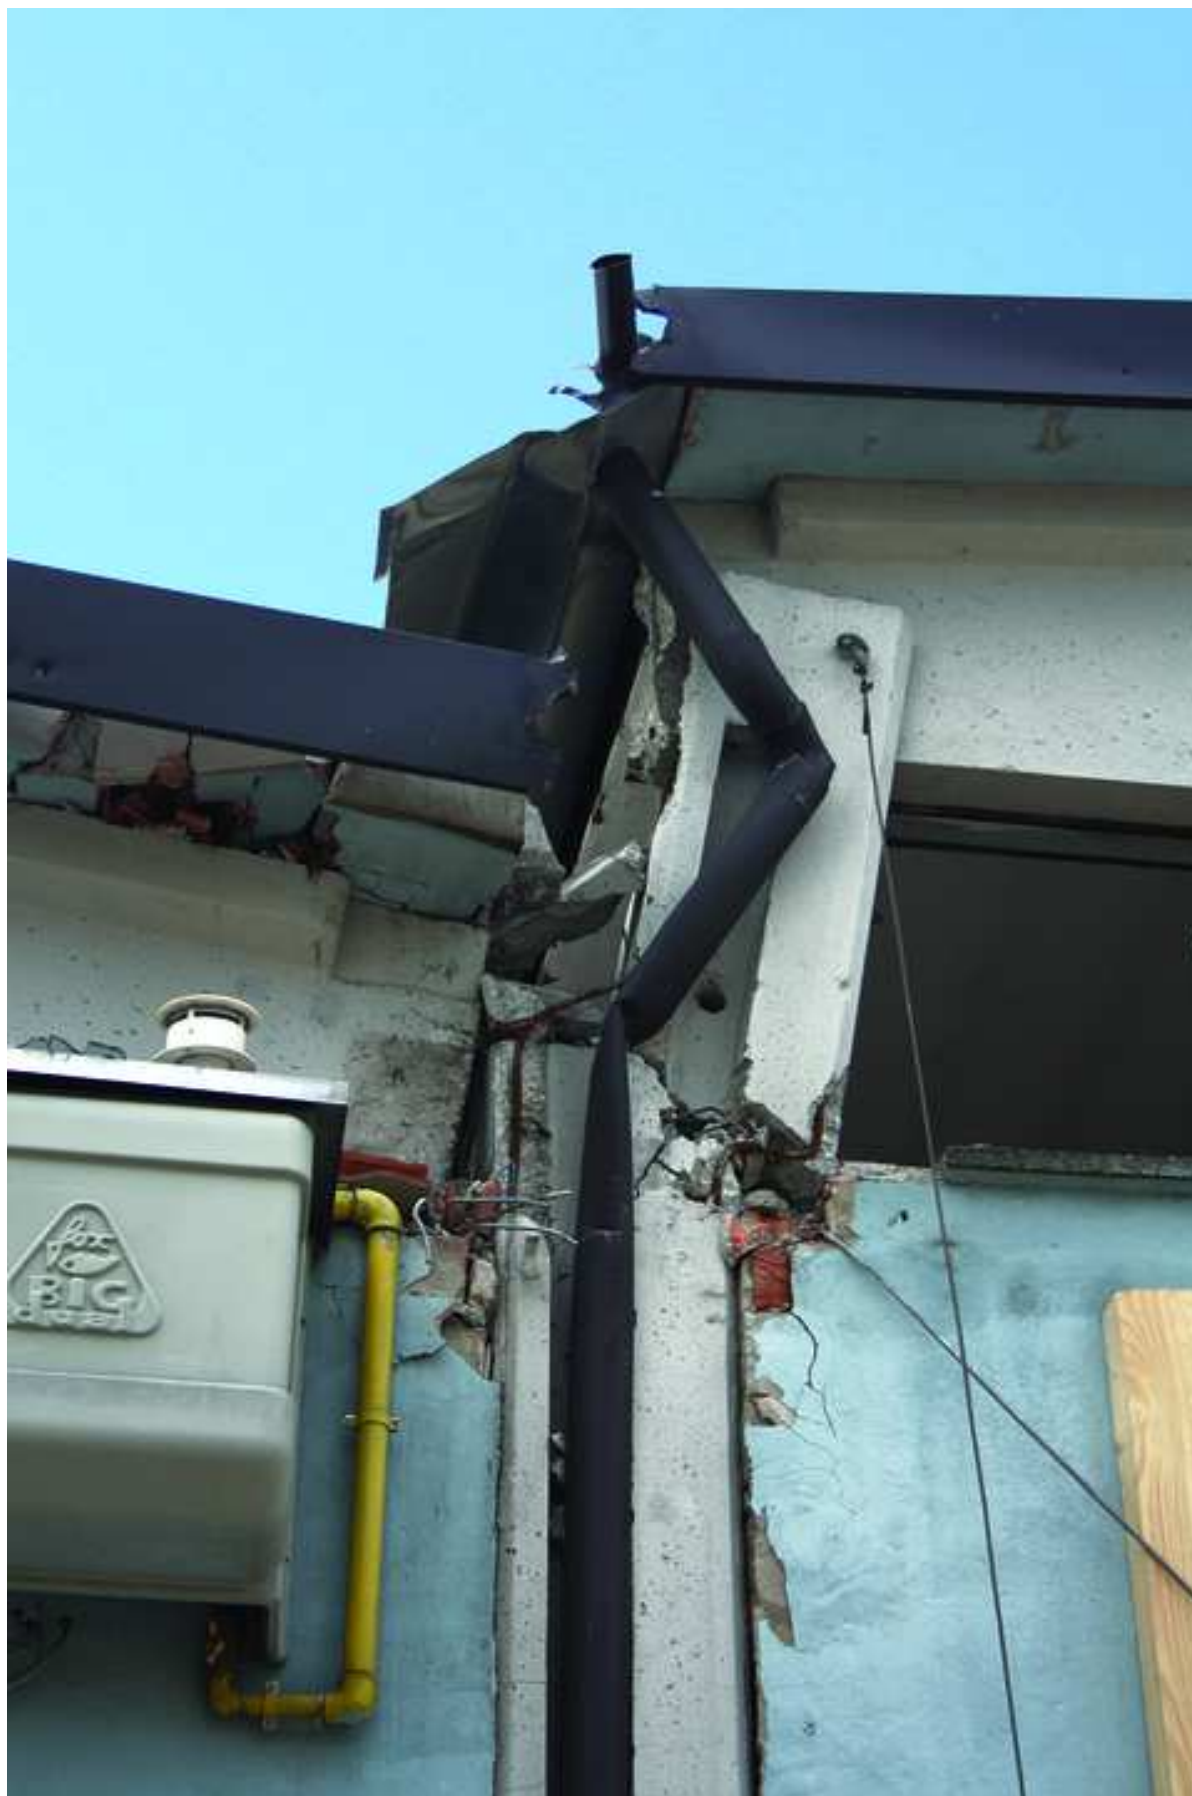
Figure 14
[Click here to download high resolution image](#)

Another column damage scenario is found in correspondence of ribbon glazing and cladding panels discontinuities where several stocky-column failures were noticed (Fig. 14). Furthermore, when RC forks were provided at the top of the columns, in more recent buildings, their flexural or shear capacities were clearly exceeded (Fig. 15), due to under-designed loads and poor detailing, therefore becoming ineffective in restraining the out-of-plane loss of the support.

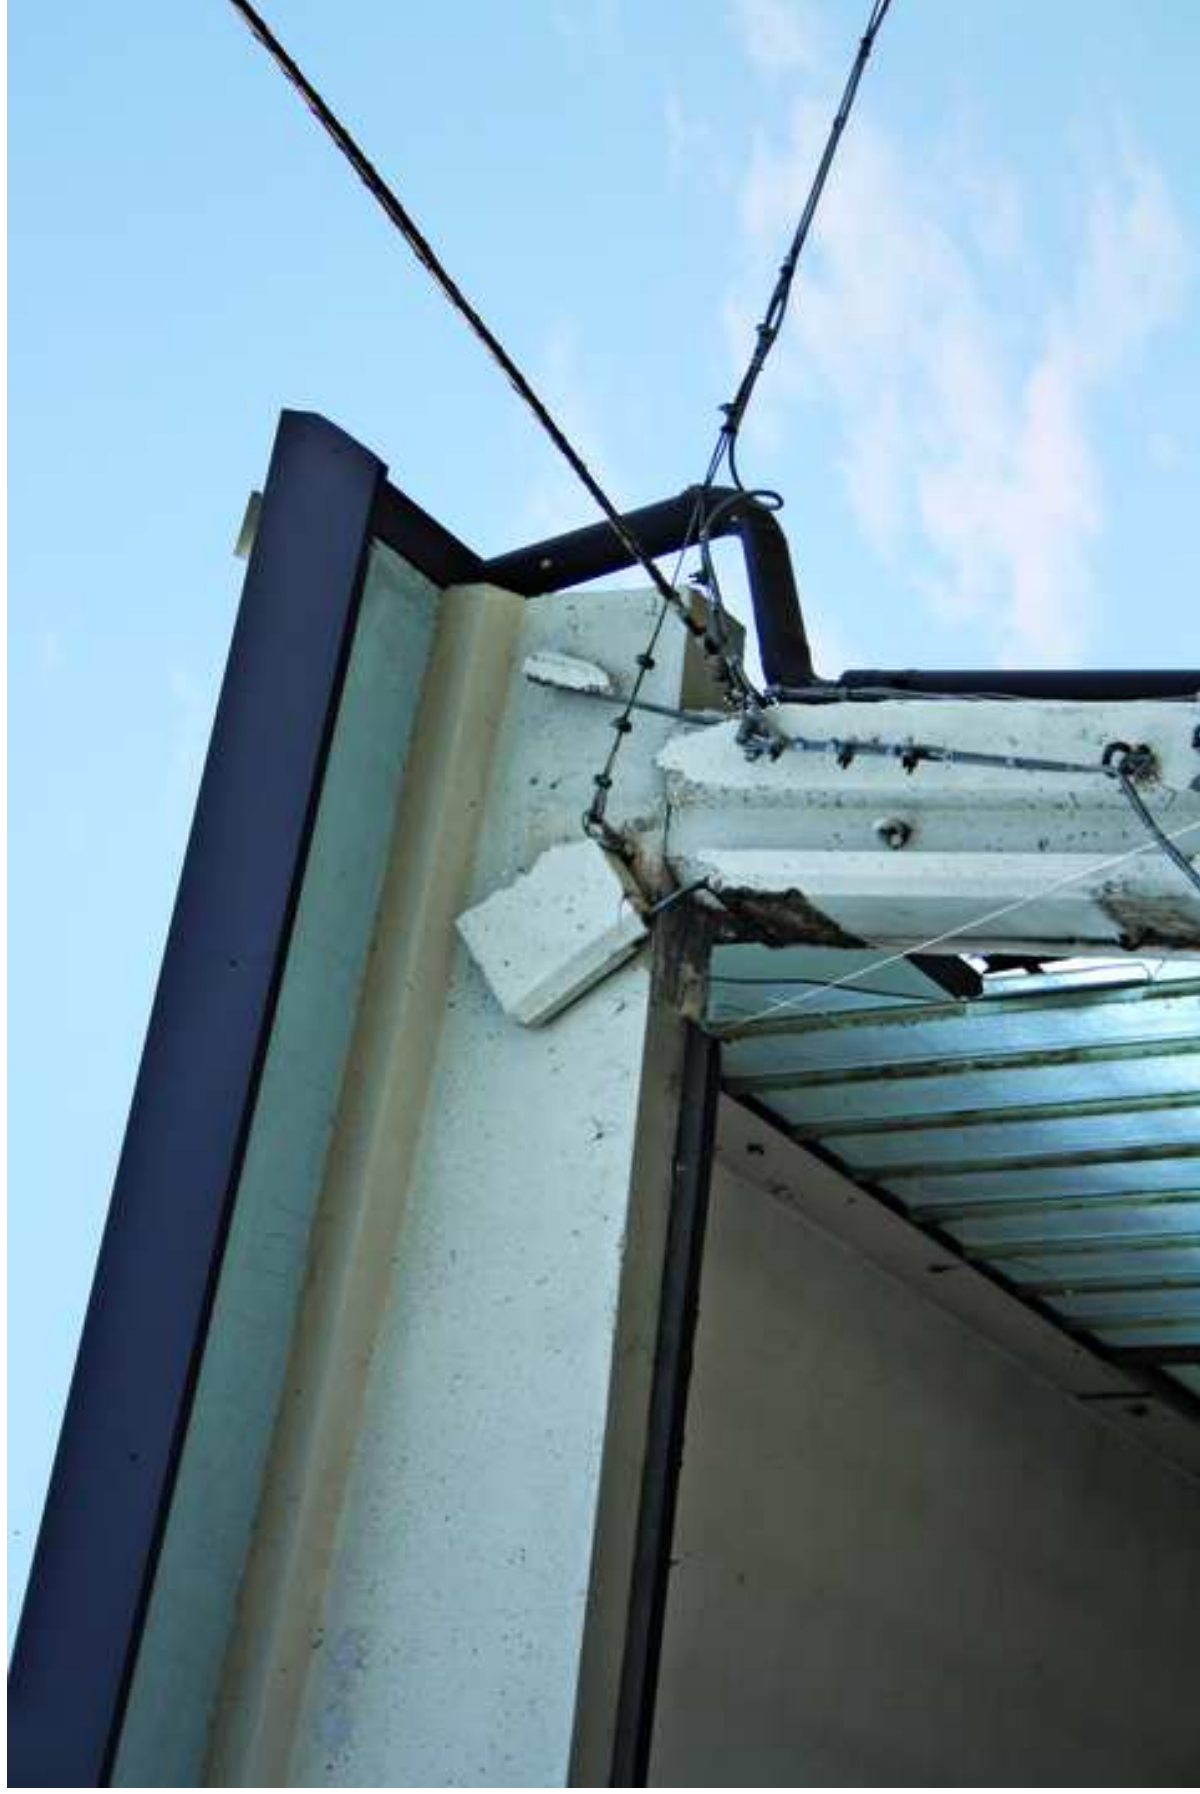
Figure 15

The flexural and shear demand on existing RC forks at the top of the columns generally exceeded the capacity, leading to the inability of preventing the out-of-plane sliding and overturning of the framing beams. In addition, the columns were in some cases proven to rigidly rotate into the isolated socket foundations.
