**Italian Joint Reconnaissance Mission**

# Türkiye

**Daily Report**  
**May 10<sup>th</sup> 2023**

## Daily report, May 10th 2023

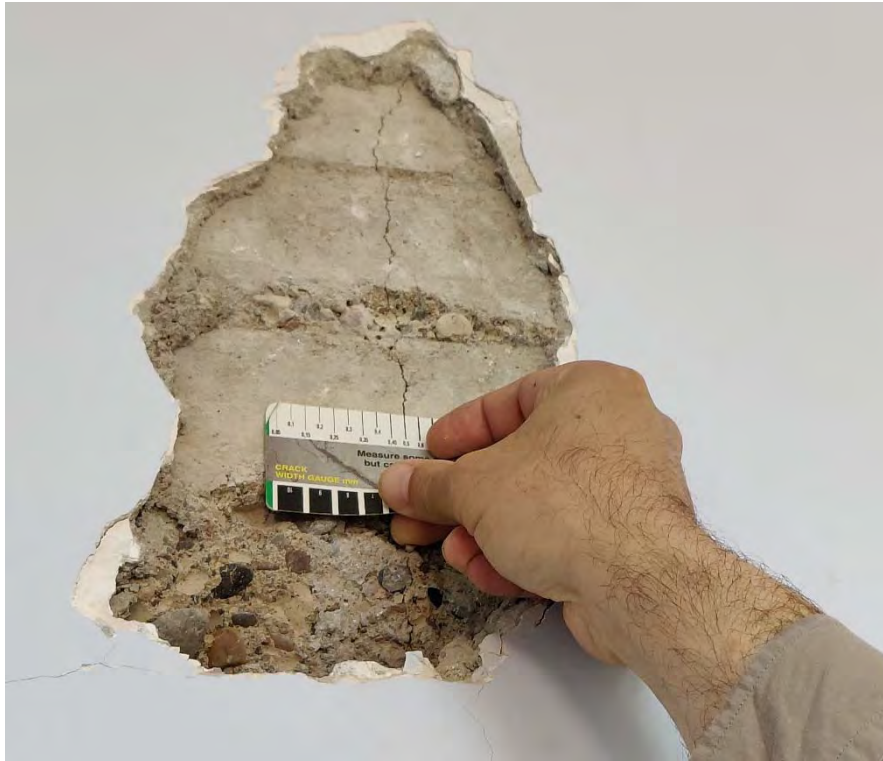
The building was classified as moderately damaged, and was temporarily closed to scholastic activities, due to flexural cracks observed on beams of the frames in the longitudinal direction, such as the one shown in Fig. 3 with a crack width of 0.5 millimeters. The building avails of a strengthening system composed by additional RC shear walls, placed near the central part and spanning the entire height of the building

Fig. 3. - Position on a flexural crack on a beam.

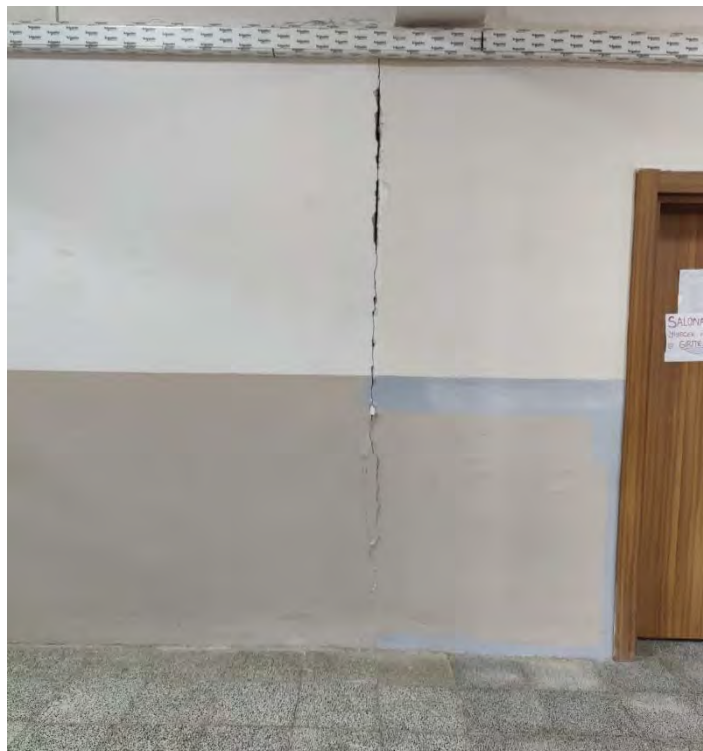
This building does not exhibit earthquake damage. All that can be observed is some separation of the masonry infill around the gym area, that was probably caused by some existing case of foundation settlement, as shown in Fig. 5. The building exhibits a strengthening system consisting of RCC shear walls spanning the entire height of the building

Fig. 5 – Separation of the masonry infill.

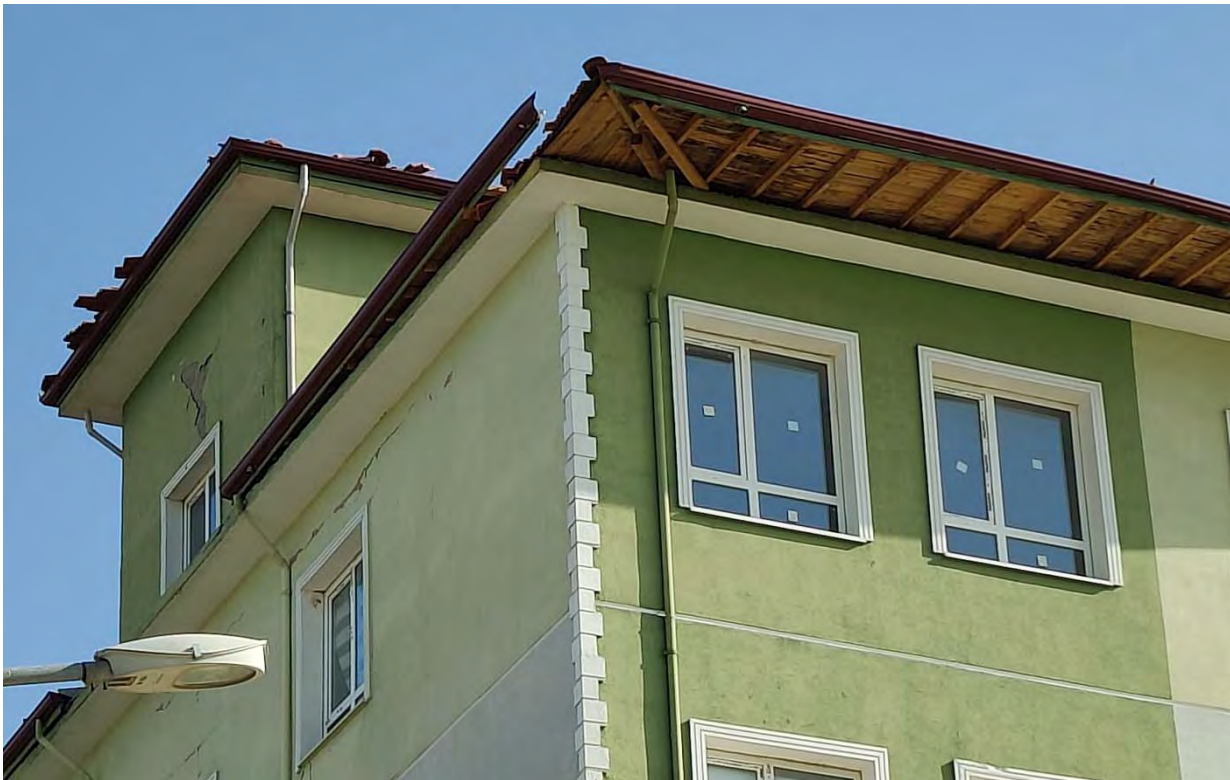
Fig. 7 – Partial collapse of the roof cover.

This building was closed to scholastic activities. It exhibits ubiquitous cracks on all sides, that only seem to concern the finishing mortar. The roof cover has evident damage, with part of it on the front side being displaced with some the roof tiles falling over.

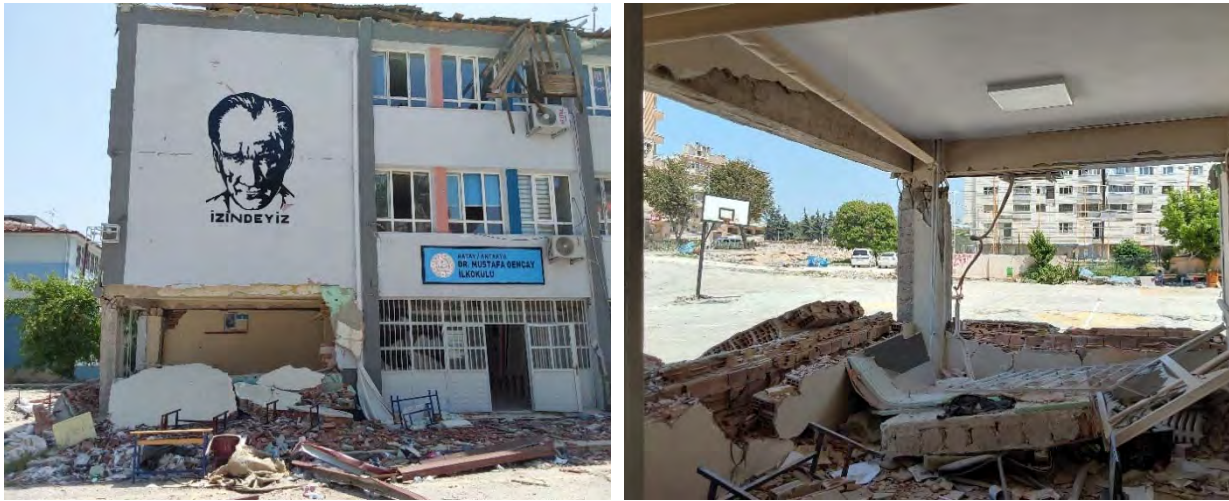
Fig. 8 Left panel: front view; right panel: view from the inside, collapsed external infill masonry walls and plastic hinging of the adjacent columns with clear disorganization of the concrete nucleus due to lack of adequate passive confinement

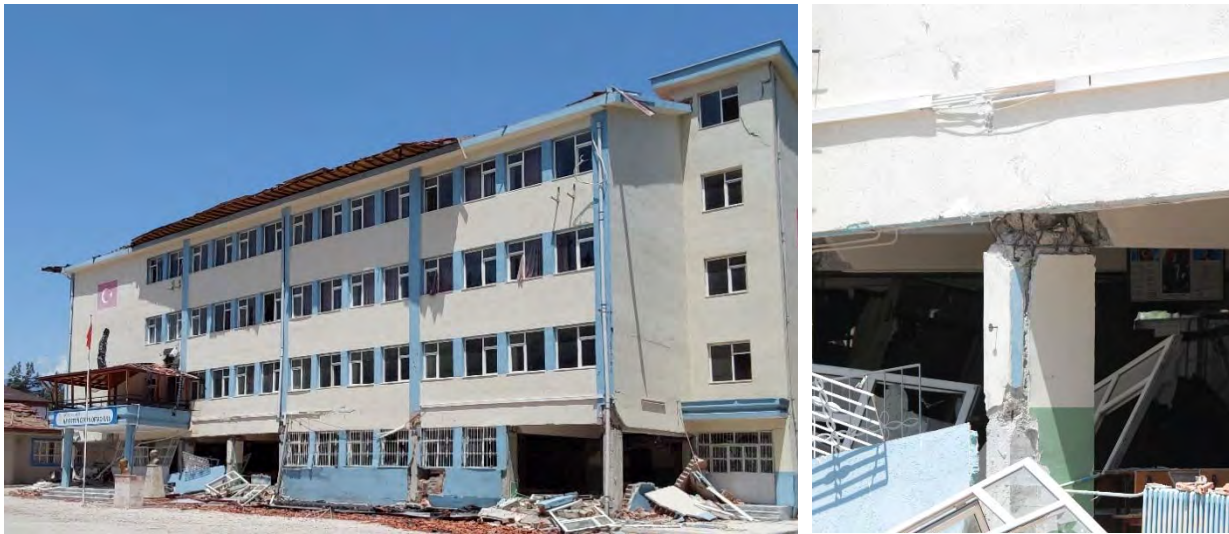
Fig. 9. Soft storey effect due to partial collapse of the front infill walls; plastic hinging of the columns.

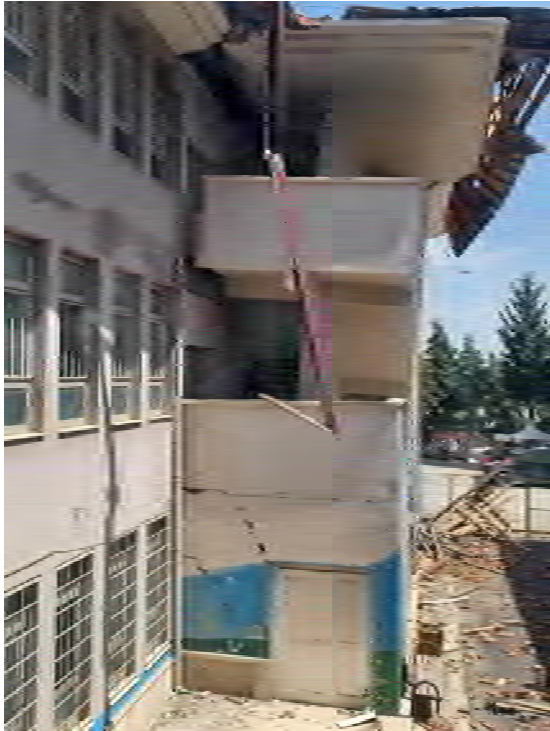
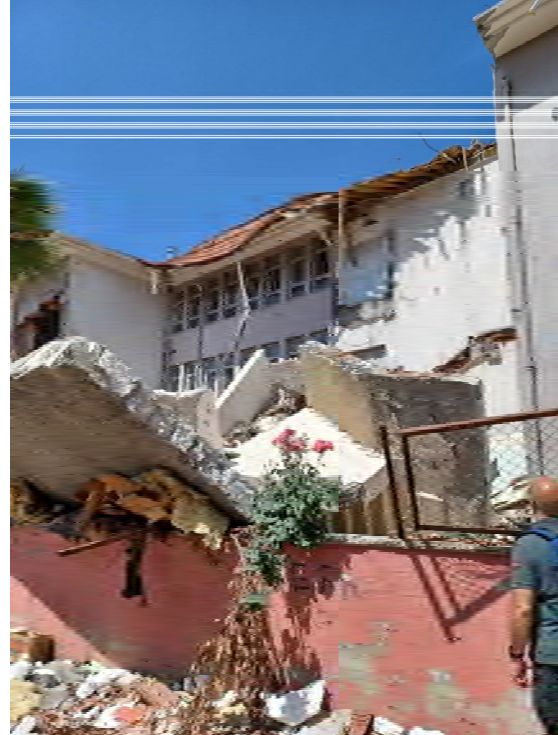
Fig. 10 Incipient (left) and total collapse (right) of the external structures bearing the emergency evacuation stairwells.

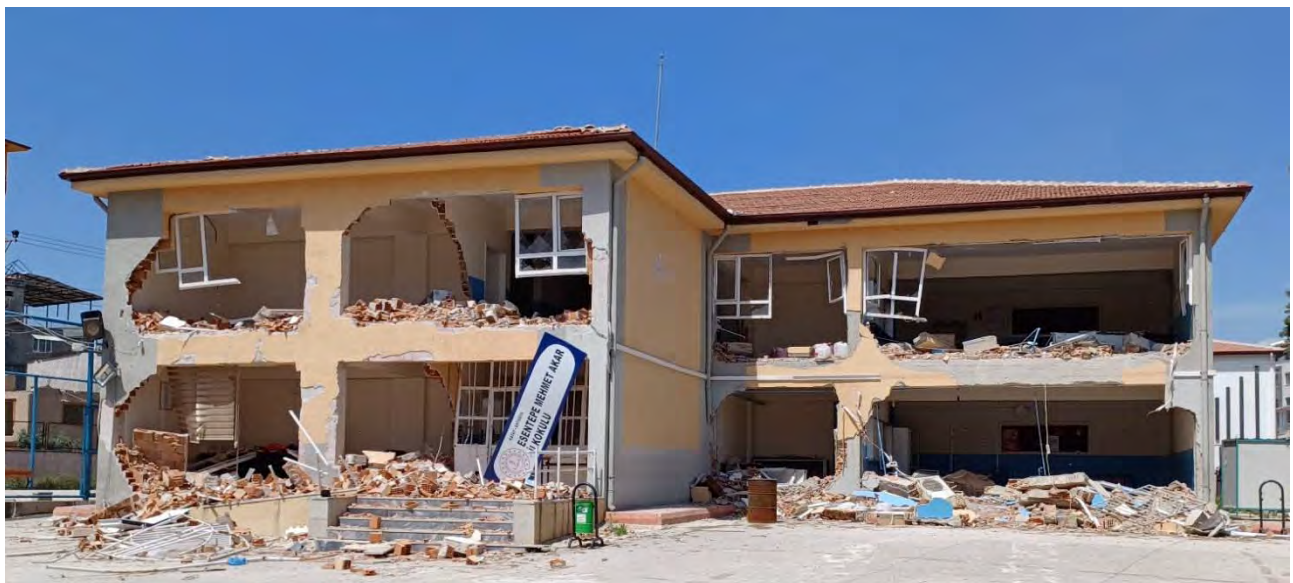
Fig. 11. Out of plane collapse of the infill walls on both floors.

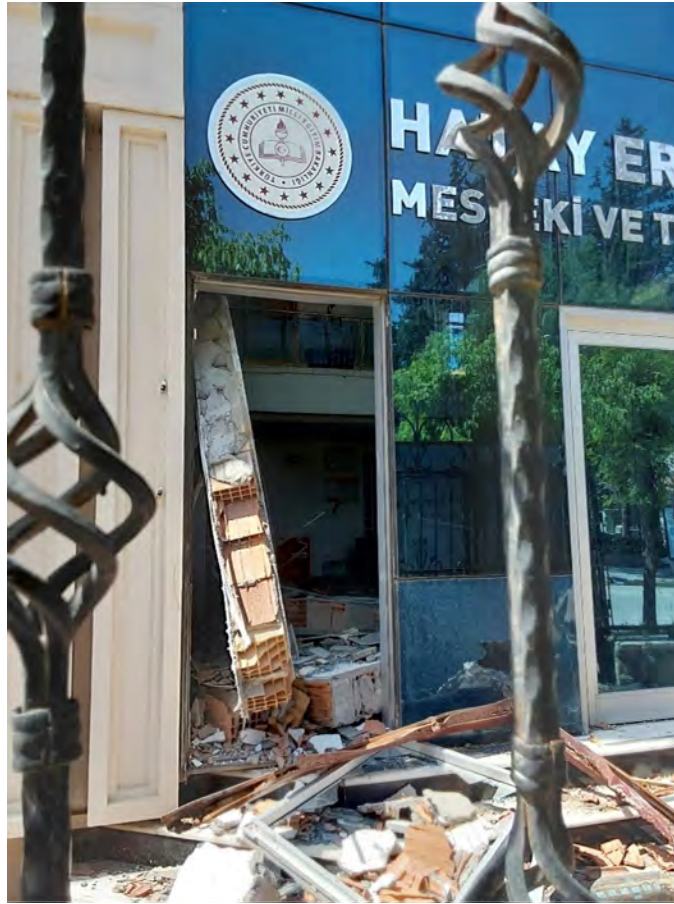
Fig. 12. Overturning of internal masonry separation walls

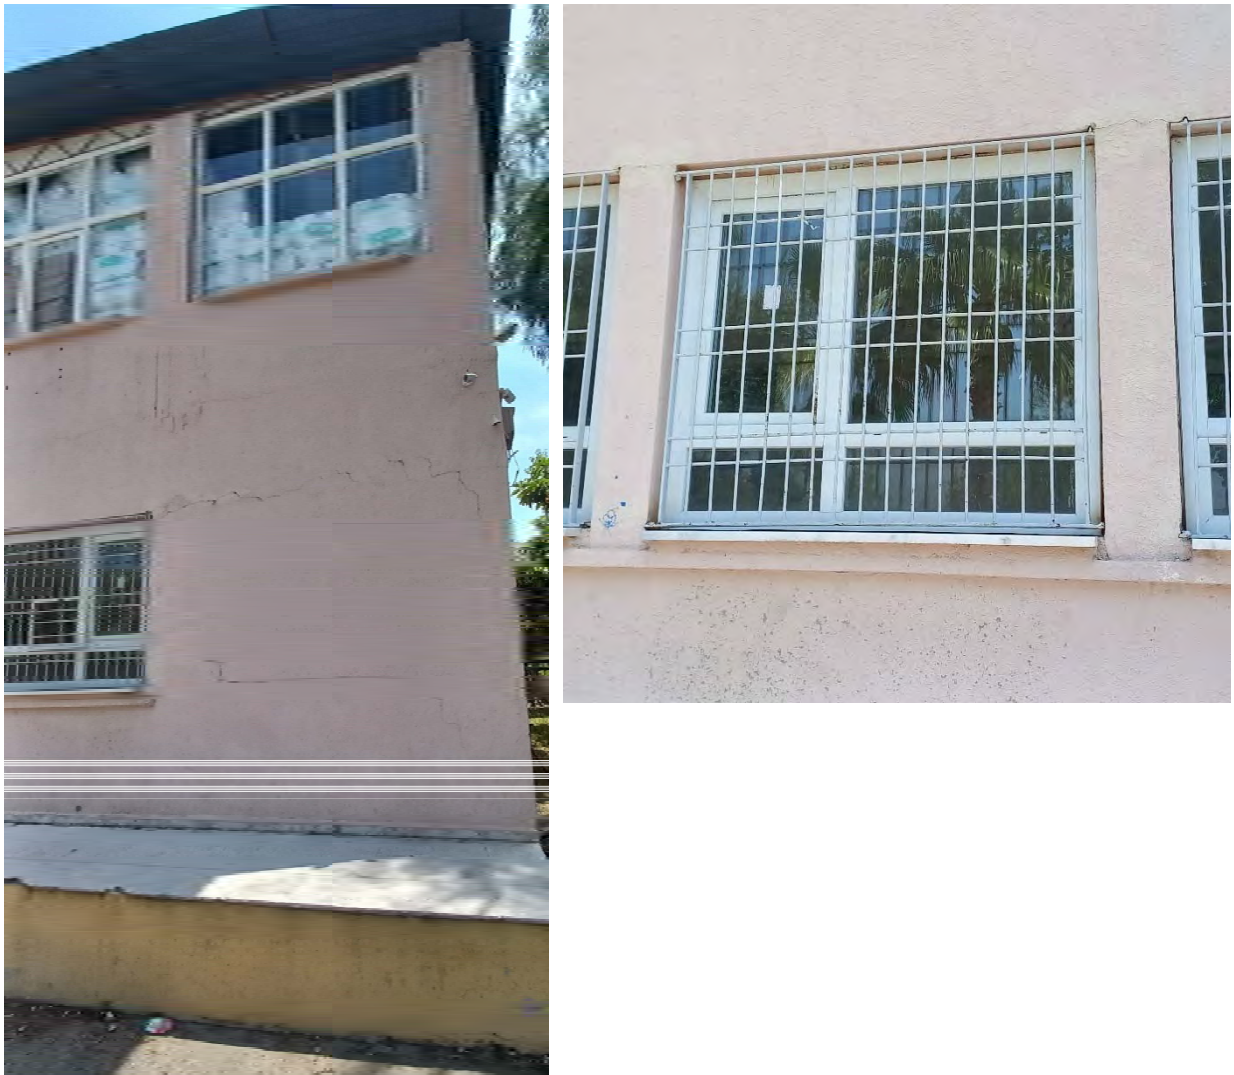
The load-bearing structures were not significantly damaged: only mild cracking was observed.

Fig. 13: Light damage at the interface of the infill walls

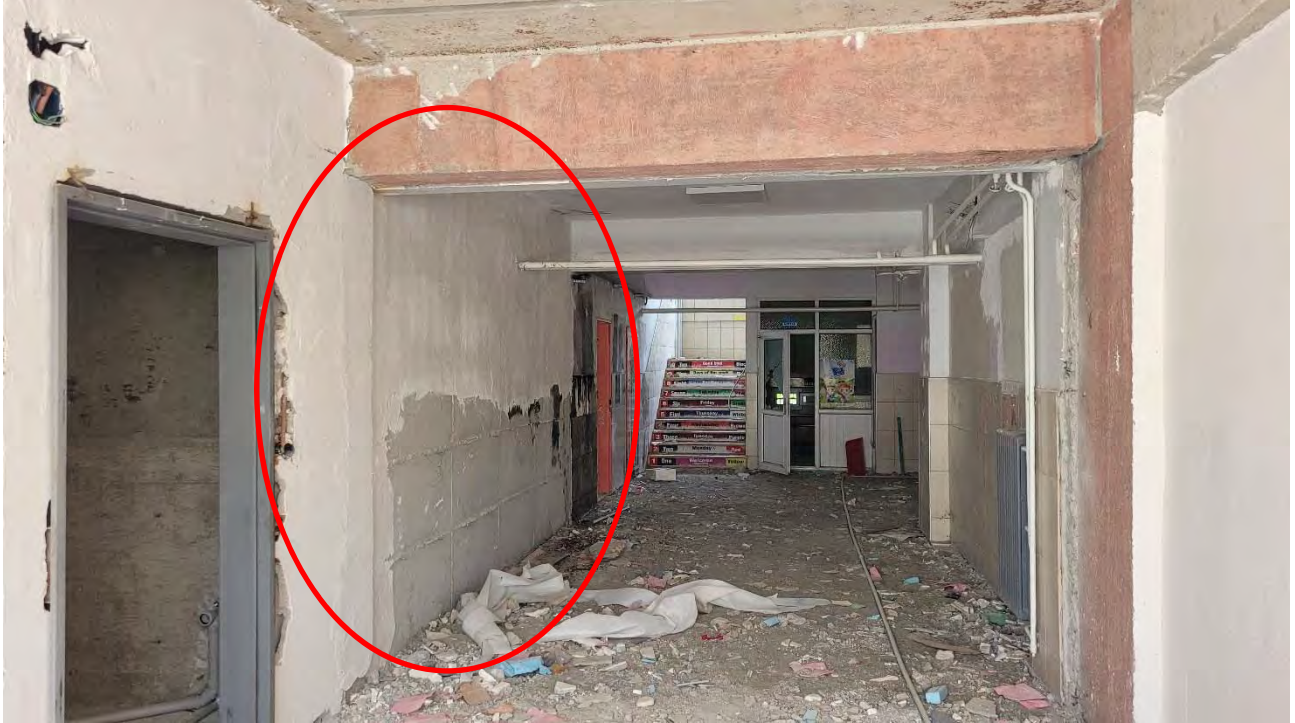
Ongoing retrofit operations that were not completed by the time of the earthquake.

Fig. 14: Additional RC shear wall.

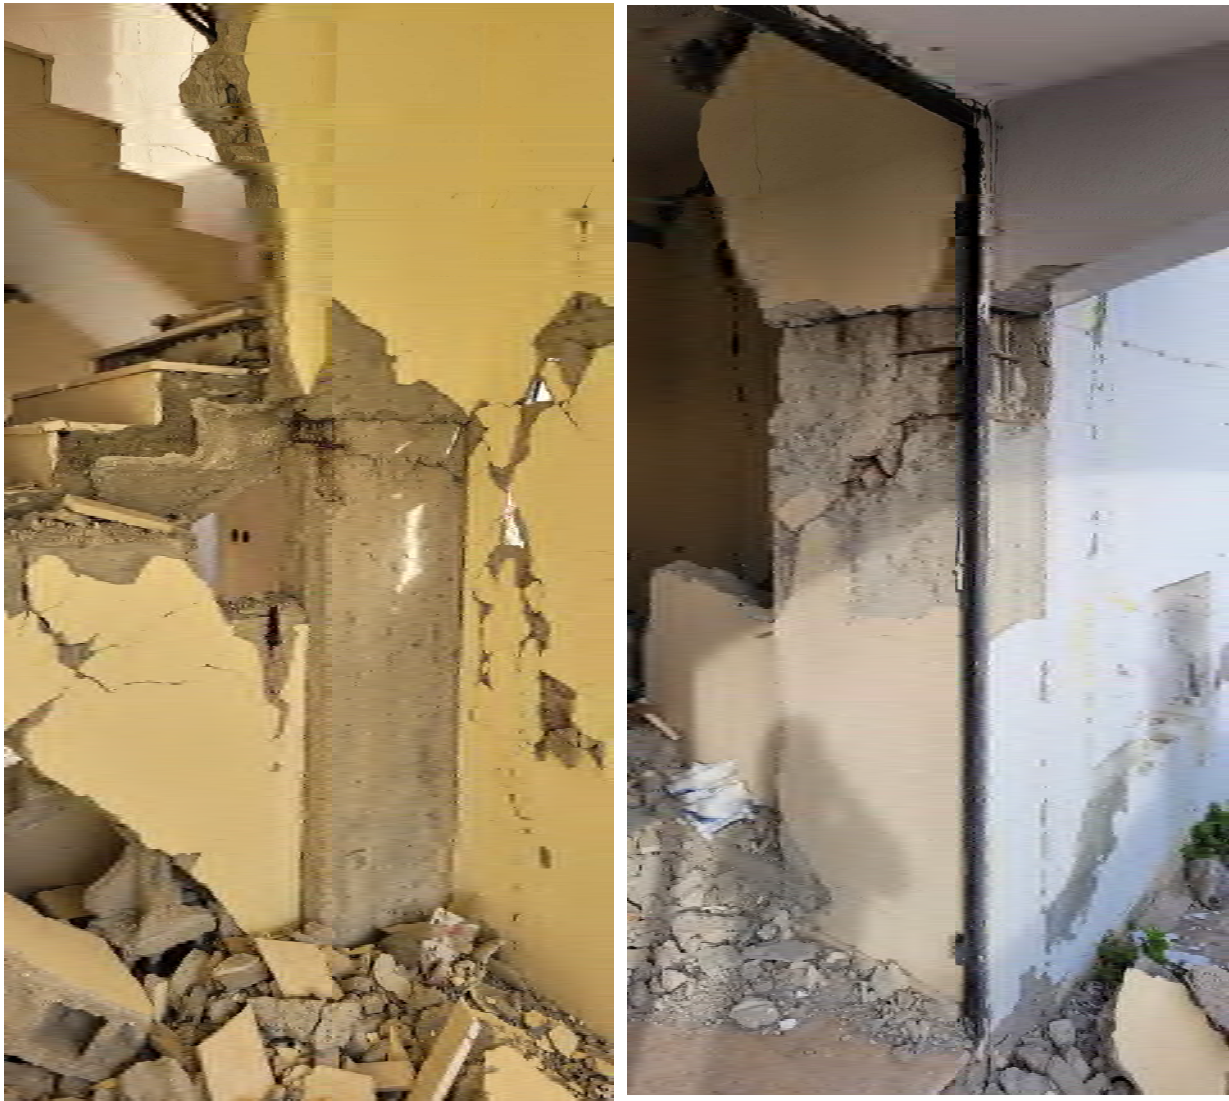
In the city of Erzin some column damage was observed near the staircase of an RC terrace.

Fig. 15: Column damage

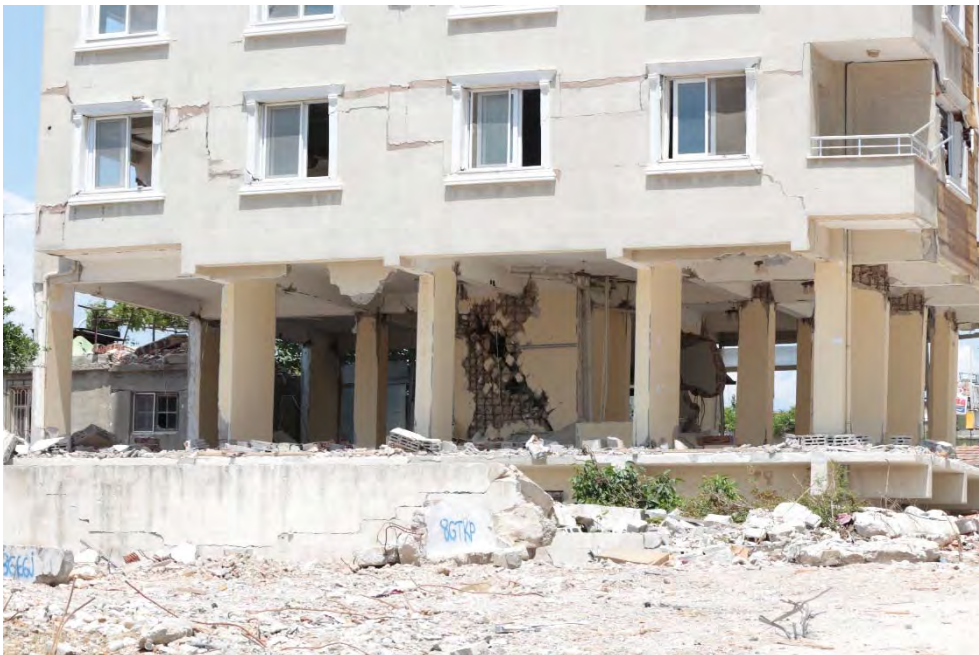
Fig. 16. Shear failure of an RC shear wall and plastic hinging at the top of the ground floor columns.

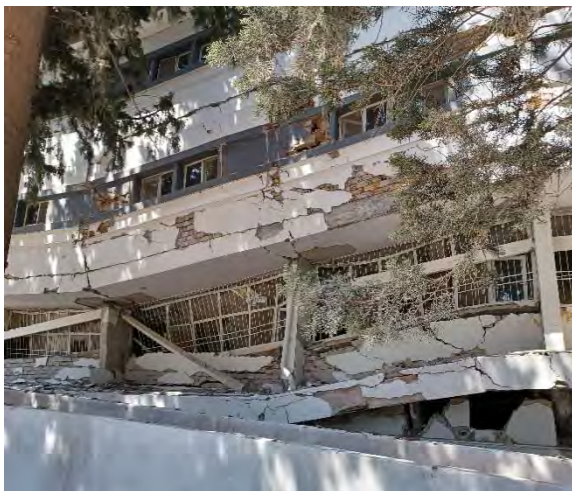
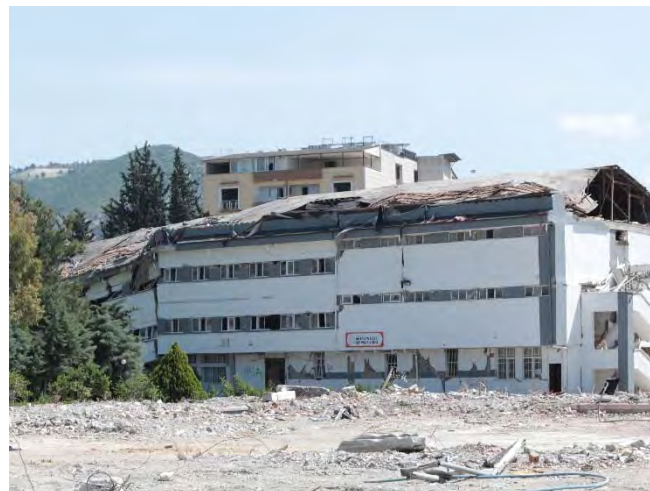
Fig. 17. Partial collapse of a large portion of a dormitory building, due to heavy damage of several consecutive columns at the ground floor.

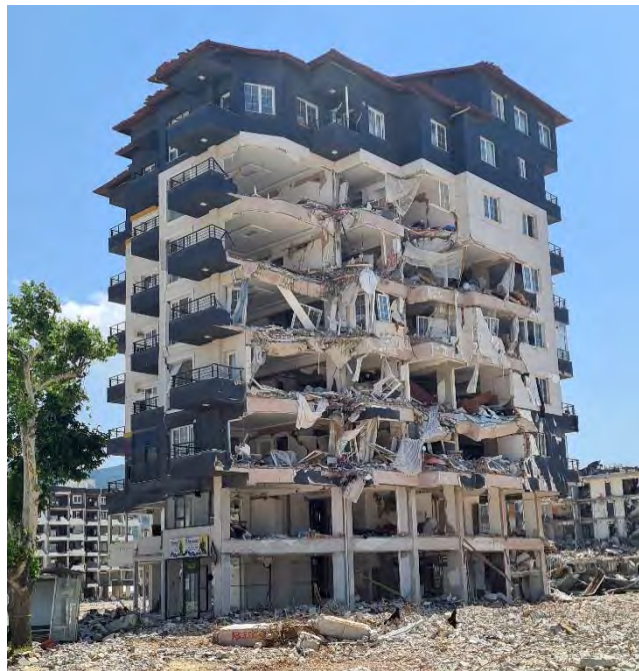
Fig. 18 Collapse of the external infill walls and damage to the perimeter beams lacking direct column support.

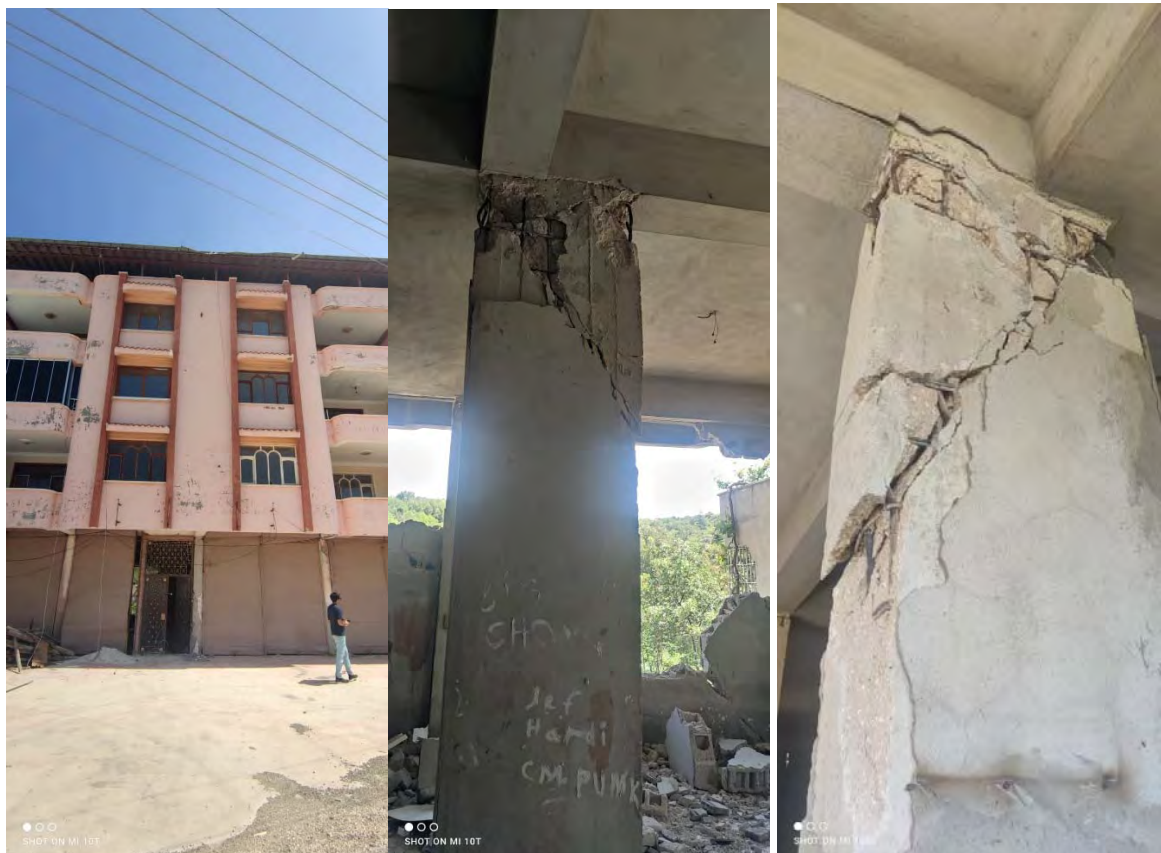
In the city of Atakoy, shear failure was observed in many RC columns in the vicinity of the stairwells

Fig. 19 Shear failure of several RC columns near the stairwells
