Italian Joint Reconnaissance Mission

Türkiye

Daily Report
May 12th 2023

Daily report, May 12th

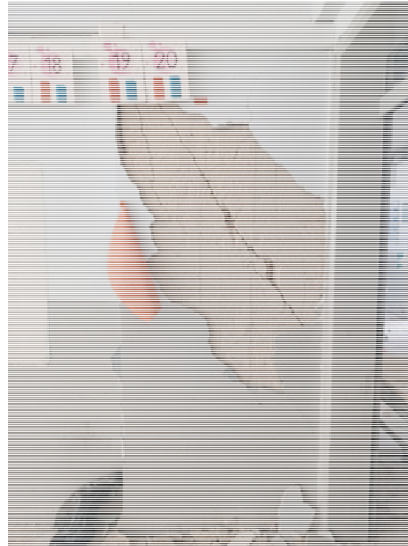
- **MUSTAFA KEMAL AKBAY İLKOKULU**

Fig. 2. Shear failure of an RC wall at the ground floor.

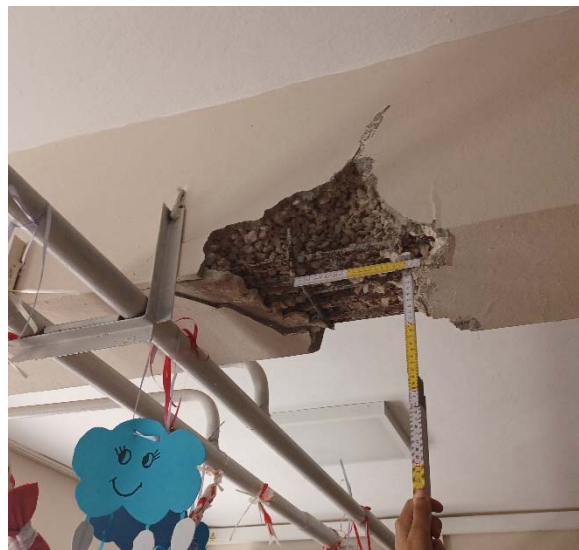
- **DURSUNLU GAZİ ORTAOKULU**

Fig. 3. Local damage in a ground floor beam, at about one-third span's length away from the nearest supporting column, at a point where heating pipes are suspended from the beam's web. Damage most probably attributed to bad quality concrete (presence of large voids and lack of hardened cement paste) and (likely) interaction with the pipe.

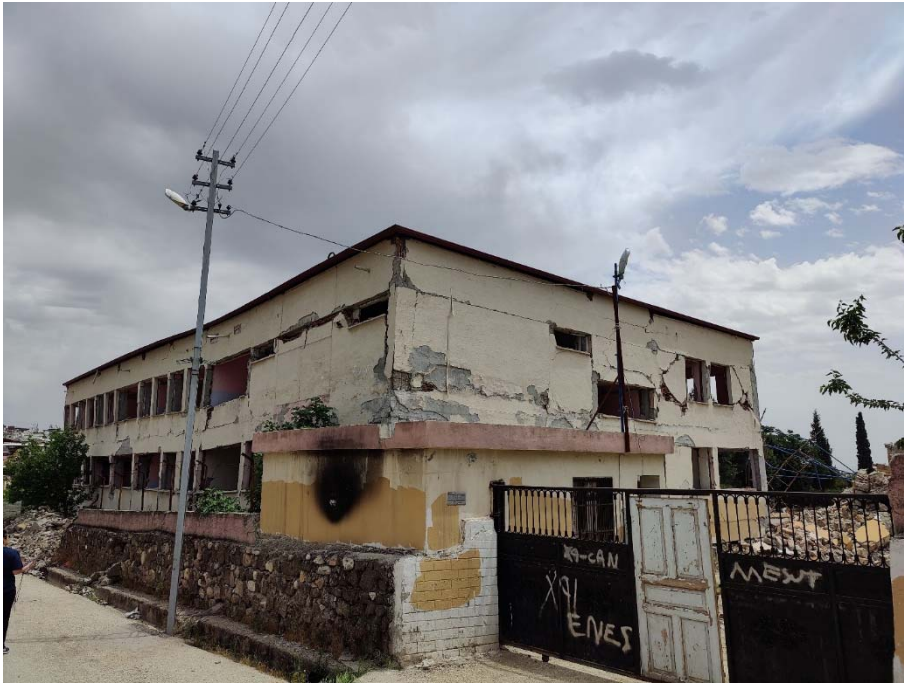
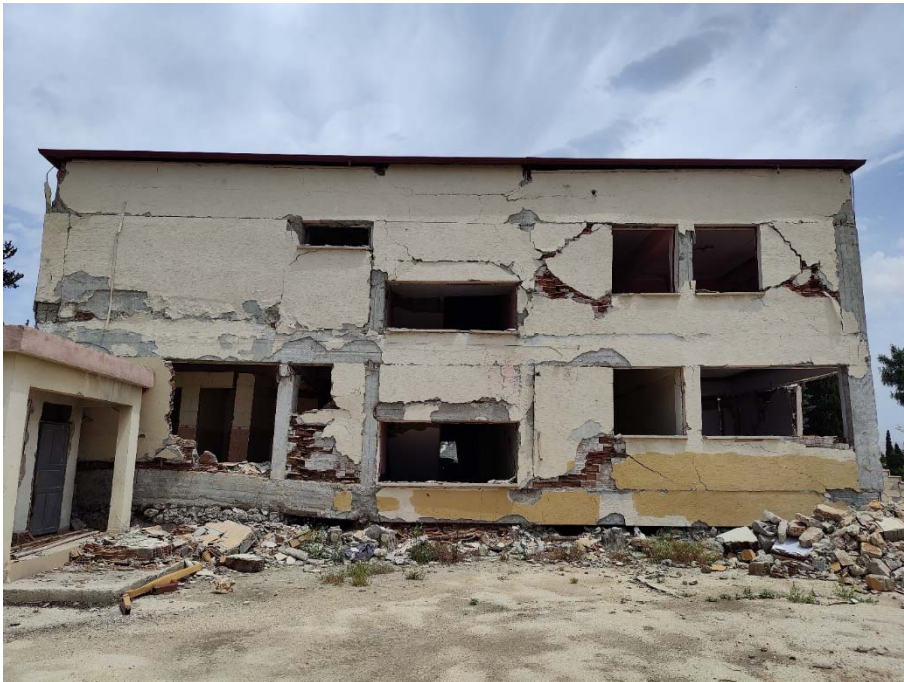
- **KAYMAKAM HASAN ZENGİNALP İLKOKULU**

Fig. 4 – Prospect view of the building exhibiting widespread damage (no documented pre-earthquake retrofit).

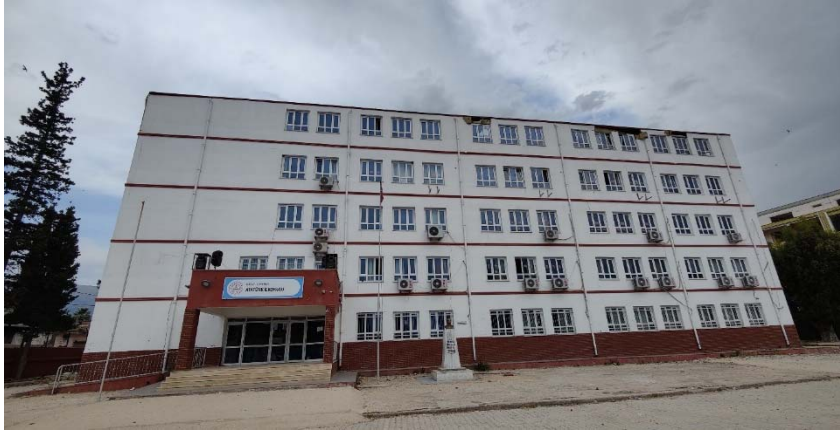
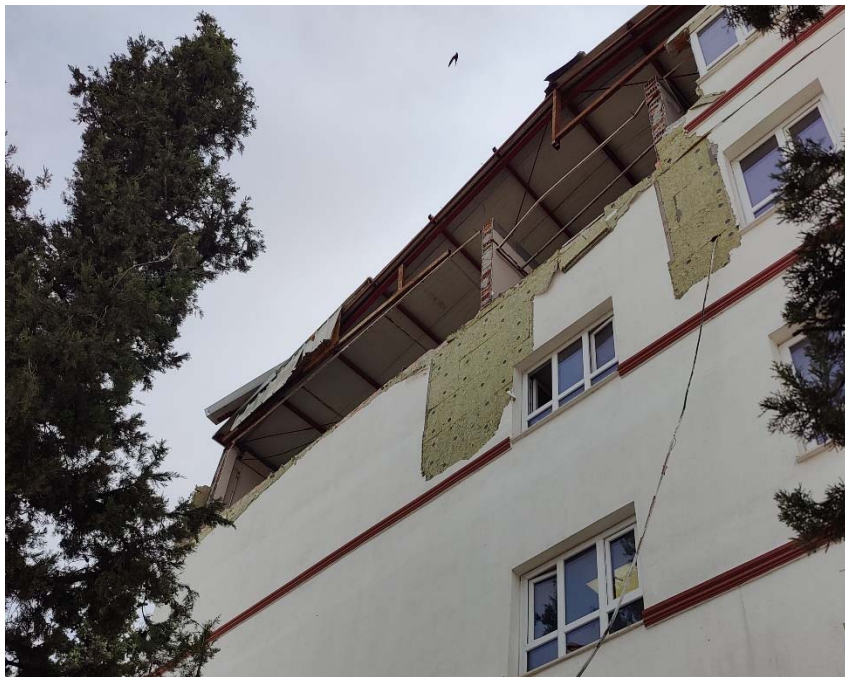
- **ATATÜRK İLKOKULU**

Fig. 5 – Front view of the building; out-of-plane collapse of the top floor’s masonry infills (building retrofitted via addition of shear walls prior to the seismic sequence).

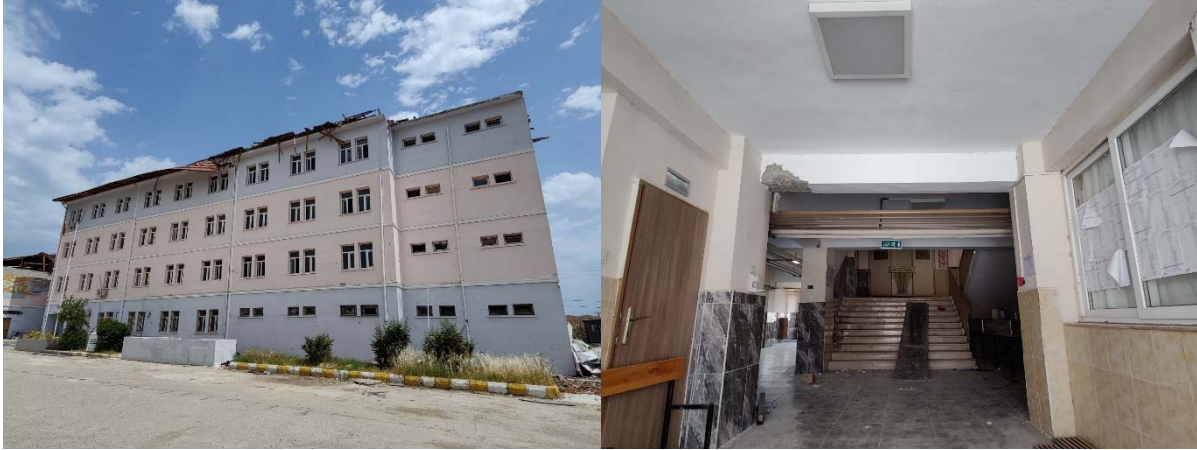
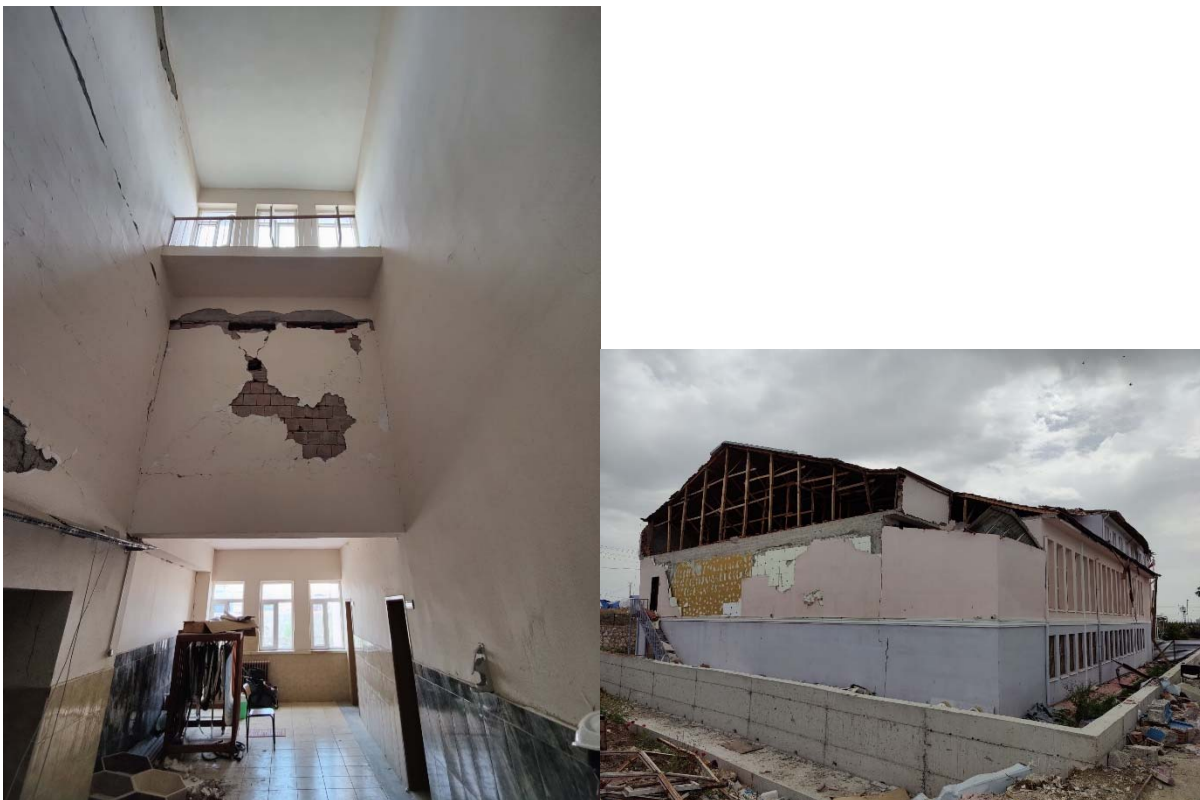
- **KIRIKHAN MESLEKİ VE TEKNİK AL**

Fig. 6 – Front view of the building, flexural cracking of a beam, damage of the masonry infills and damage to the roof cover.

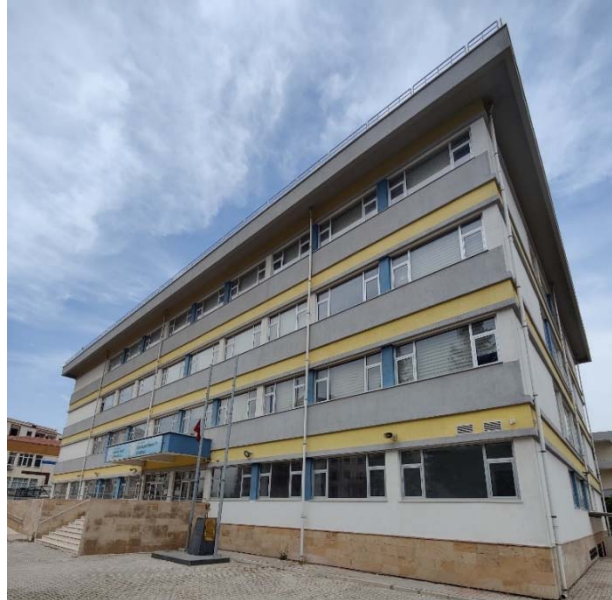
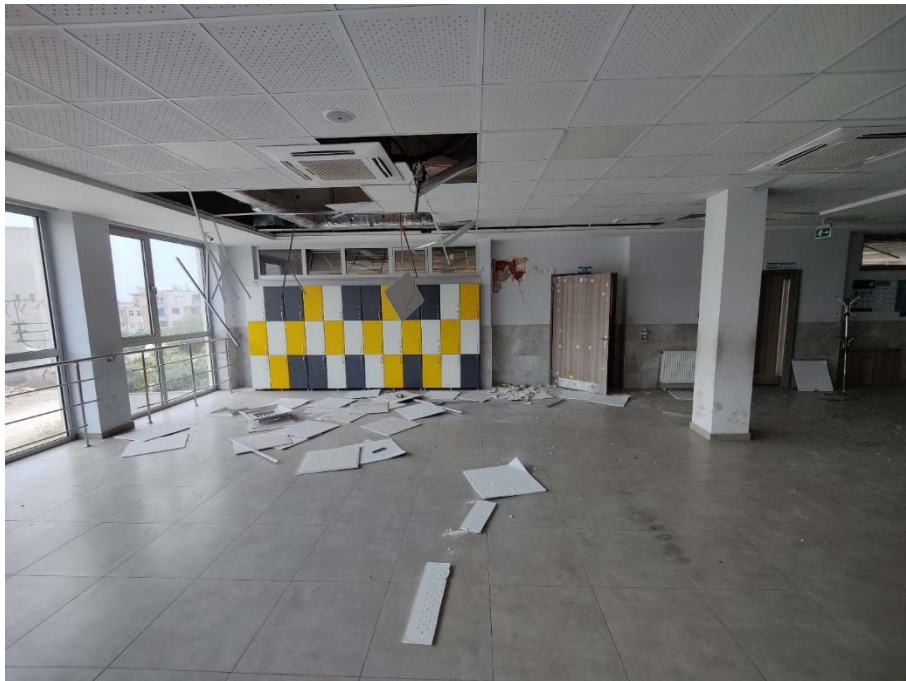
- **YUNUS EMRE ORTAOKULU**

Fig. 7 – Front view of the building and fallen suspended roof panels.

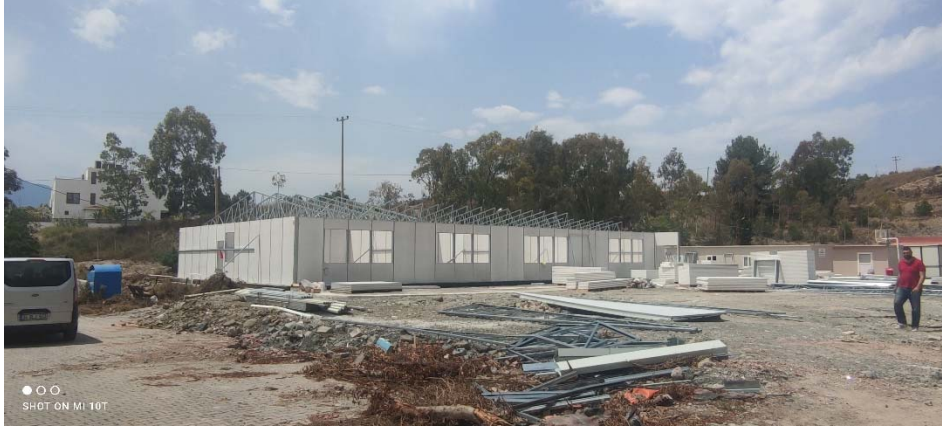
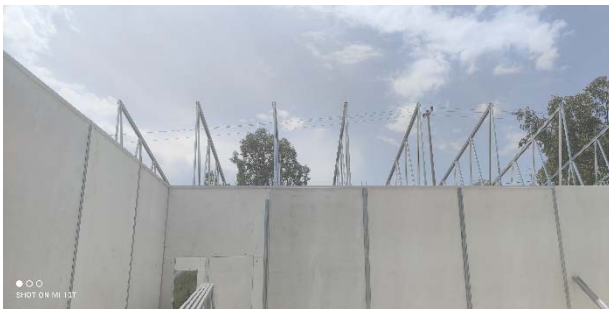
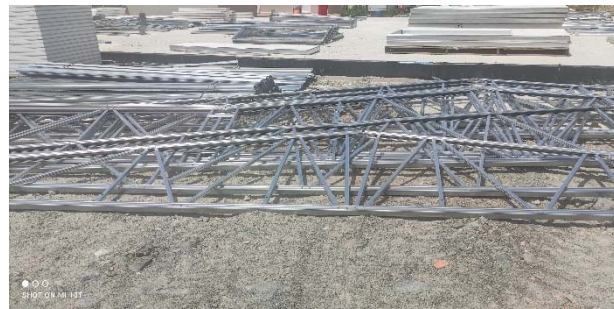
- **ULUÇINAR İLKOKULU**

Fig. 8 – Original school building has been demolished despite lack of serious damage and is being replaced by single-storey building (a), using prefabricated sandwich panels with polystyrene (b) and roof structure consisting of lightweight aluminum trusses (c). The choice of structural system was dictated by the low bearing capacity of the foundation soil, which led to opting for replacement with a lighter structure, rather than retrofitting the existing structure with shear walls.

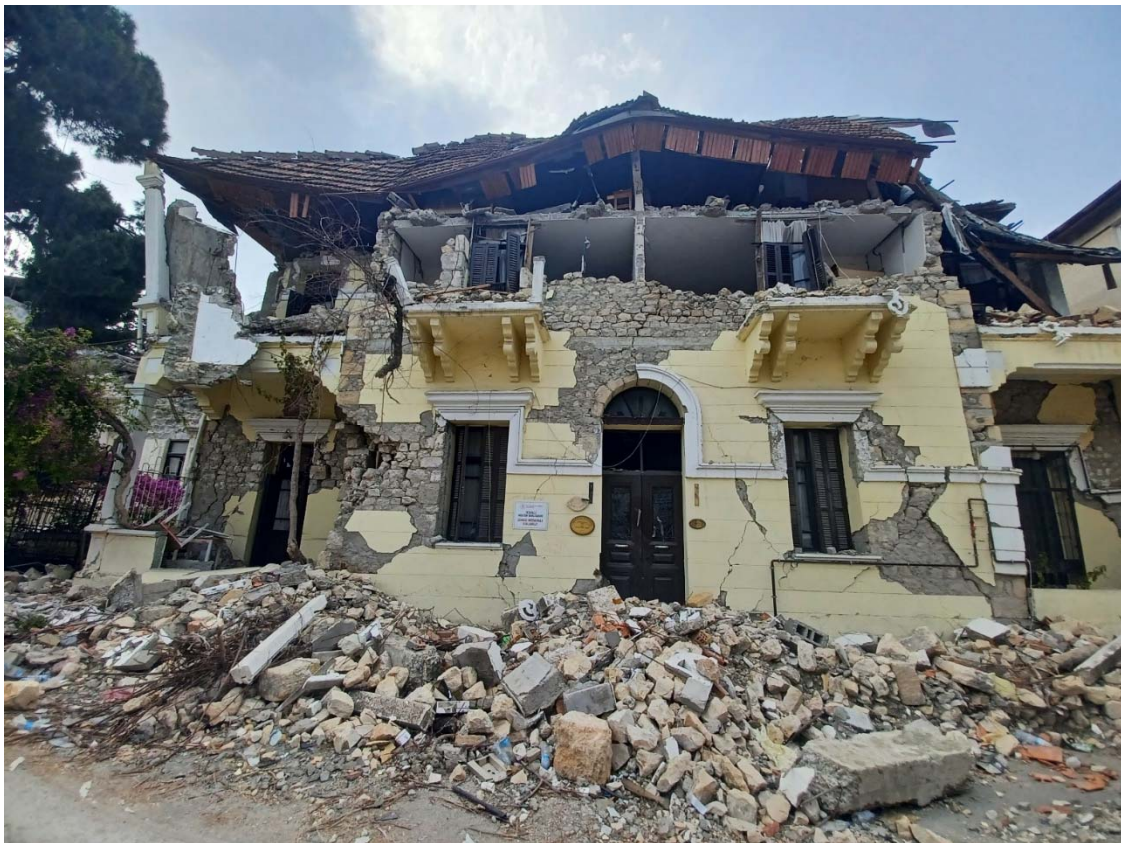
- **City of Antioch (Antakya)**

Fig. 9 - Damage state of a stone masonry building in the historic city-center of Antioch: collapse of the roof, in-plane and out-of-plane failure mechanisms of the masonry walls. The cantilevers of the balconies overlooking the main entrance have survived, oddly enough.

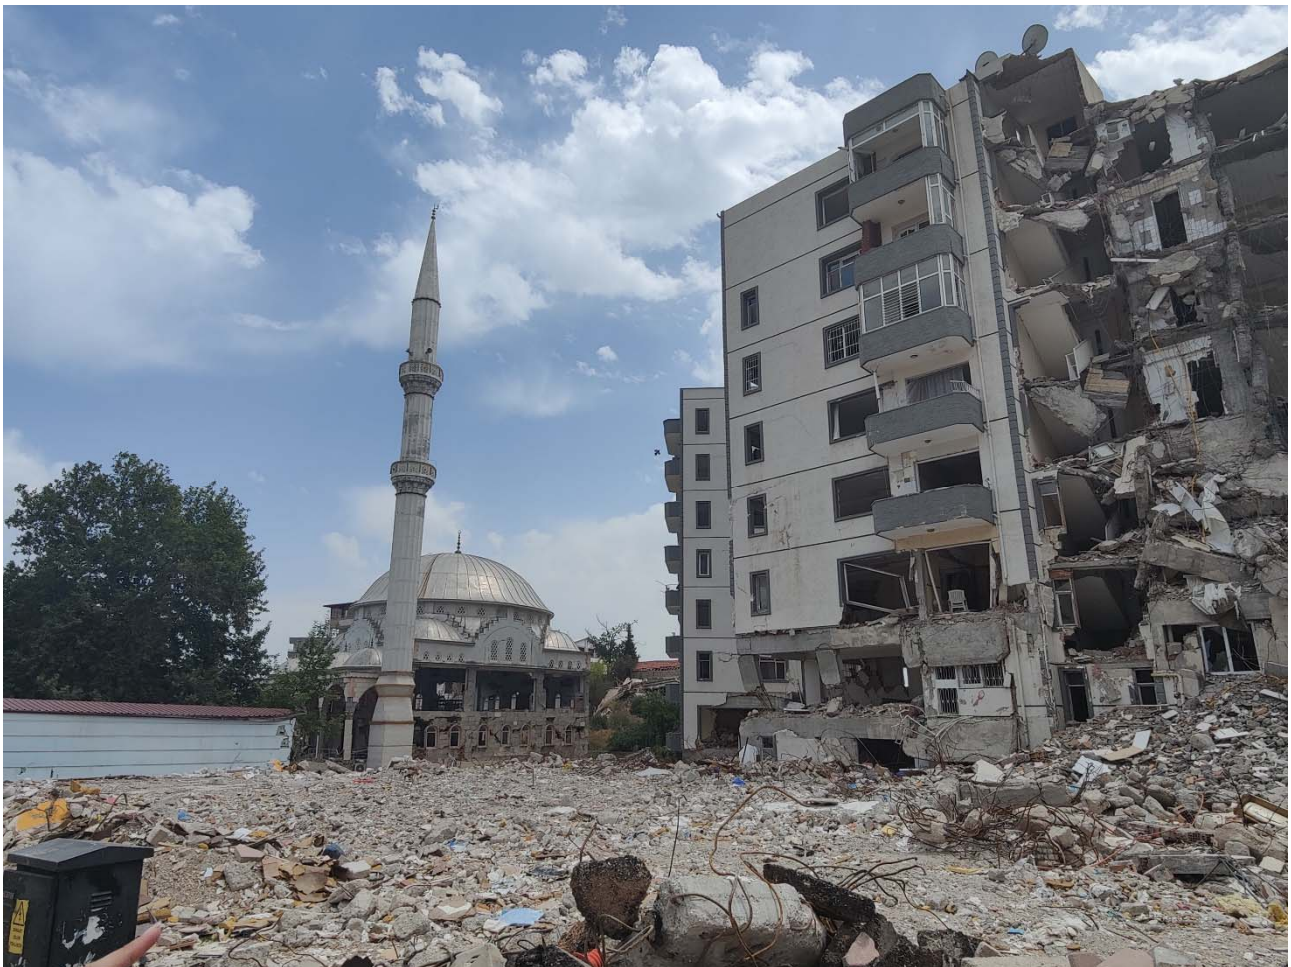
Fig. 10 – Residential complex in downtown Kirikhan.

Damage was encountered in a residential building in downtown Kirikhan, visible on the right-hand side of Fig. 10, where one can observe a floor-sway failure mechanism on the first two elevations of the left portion of the building and partial pancake collapse on the right portion. On the left-hand side of the picture, a mosque is visible, with evident damage on the external front walls, in the form of shear cracks and an apparent deviation from the vertical position of the minaret, which does not seem to have suffered other serious damage.

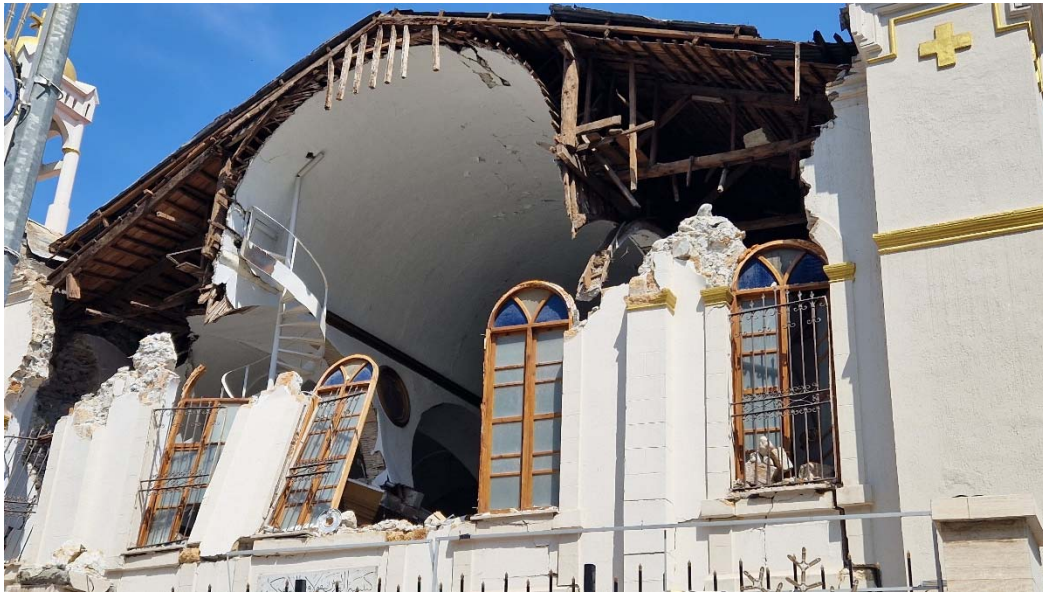
- City of Kahramanmaraş

Fig. 11 – Collapse of the frontal wall of a masonry church with a wooden roof.

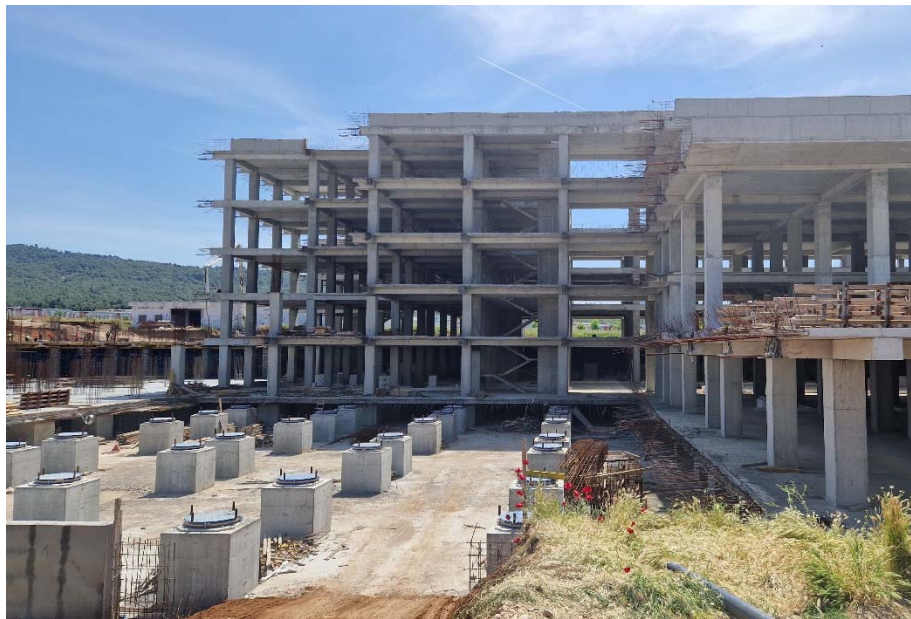
Fig. 12 – Side view of the structure under construction.

The building still under construction is a cast-in-situ RC structure and avails of a base-isolation system, supported by a bore pile foundation, where the piles were connected via a 1.5m-thick RC foundation slab acting as pile-cap. The deep foundation system was presumably adopted due to the poor bearing capacity of the soil. The base-isolation system consisted of 361 1.0m diameter, double-curvature friction-pendulum isolators, with maximum stroke of $\pm 1000\text{mm}$, which was justified by the construction site manager as a design choice dictated by the vicinity of the site to the fault (distance of less than 10km). The isolators' dimensions are compatible with the displacement spectra derived from the acceleration records obtained at nearby stations.

The superstructure consists of a bidirectional space frame with 40x80cm web T-beams and columns with square cross-section that varies from 70x70cm to 90x90cm, and span lengths of about 7.0m. The stairwells also availed of RC shear walls. The floors are two-way RC slabs and the number of floors is 5 with inter-storey heights varying between 5.0 and 5.4m. The foundation slab is 150x120m in plan. It should be noted that the new superstructure is devoid of expansion/seismic joints.

On the perimeter of the first elevation floor slab, a 2.0m span of RC slab cantilevers out. This perimeter cantilever ends at a distance of 4.0cm from the rim of the underlying retaining wall. After the earthquake, an approximate measurement indicated that the residual displacement of the isolation devices was around 3.5cm.

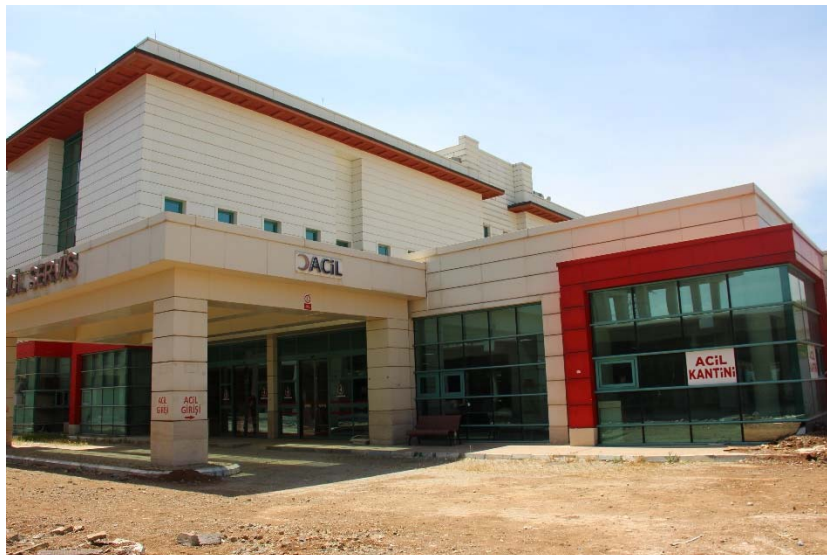
Fig. 13 – Existing hospital building built in 2012.

The second structure under inspection (the existing one), has a more traditional lateral-load-bearing system, comprised of mixed RC frames, that is frames connected to shear walls, with monolithic connection to the foundation. That structure was found to exhibit damage at the end sections of the linear (beam/column) elements in the vicinity of the stairwell. Further damage was observed at the masonry infills (Fig. 14) and non-structural components.

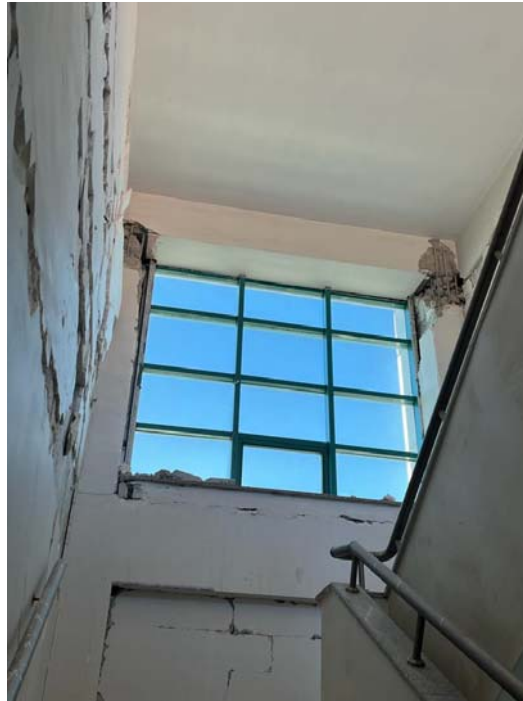
Fig. 14 – Damage encountered in the existing structure.
