Seismic performance of non-structural elements during the 2016 Central Italy earthquake

D. Perrone¹ · P. M. Calvi² · R. Nascimbene³ · E. C. Fischer⁴ · G. Magliulo⁵

Keywords Non-structural elements · Central Italy earthquake · Post earthquake reconnaissance

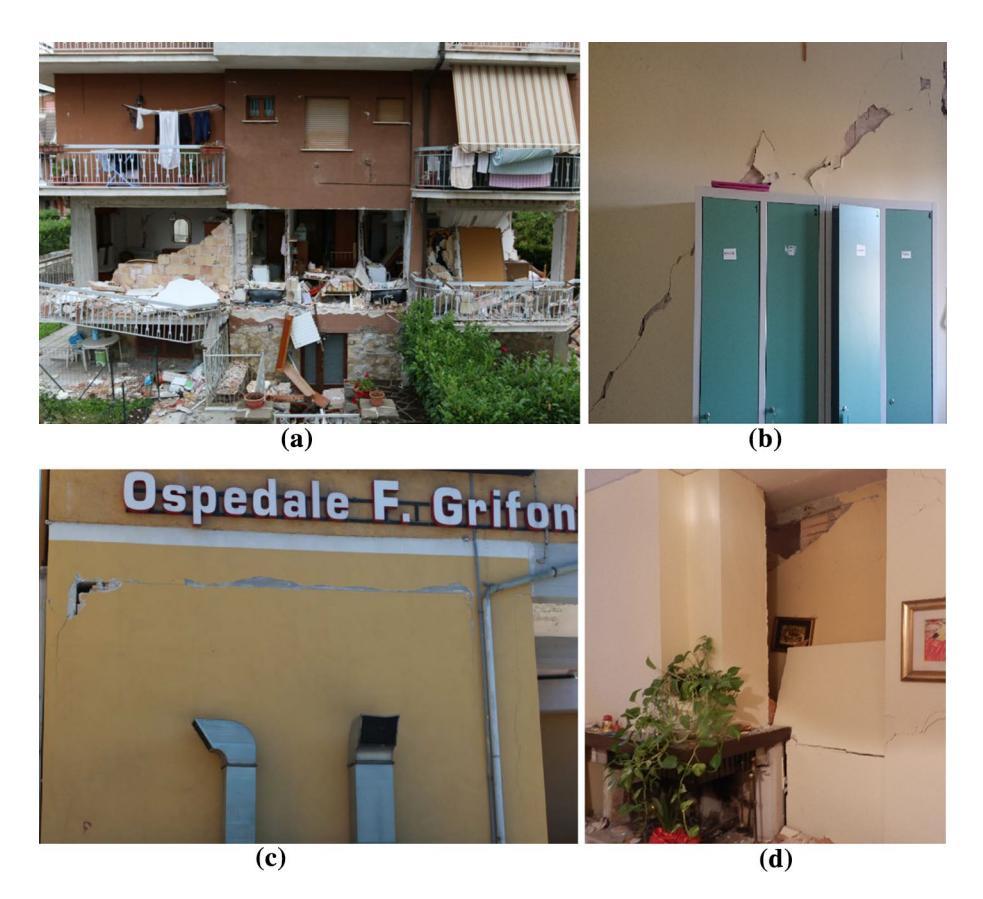
Extensive damage to internal and external masonry infill walls was observed after the 2016 Central Italy earthquake (see Fig. 4). The infill walls are typically classified as drift-sensitive NSEs. Their in-plane response is governed by the inter-storey drift of the structure during the ground shaking. However, the out-of-plane response of infill walls has been observed to be significantly affected by floor acceleration demands, in particular if

Fig. 4 Typical damage to masonry infills. a Collapse of infill panels, b diagonal cracking, c crushing in the corner, d internal partition

heavy secondary systems, such as coating panels or signs and plants, are connected to the masonry infills increasing the inertia forces. The damage to masonry infills was mainly attributed to the fact that most of the buildings in the affected areas were designed and built prior (pre-1970) to the development and implementation of modern design provisions. As a consequence, a large number of the inspected structures appeared to have experienced excessive lateral drift because of their insufficient lateral stiffness. The gaps suggested by the international codes, in order to avoid the interaction between infill walls and surrounding RC frames, were not observed during inspections. Typically, the masonry infill damage is initiated by the disconnection between the panels and the surrounding frame (Fig. 4c), which triggers a "diagonal strut" mechanism. At high drift demands, the strut mechanism leads to the development of diagonal cracks (Fig. 4b), to crushing in the corners (Fig. 4c) or to the complete failure of the masonry panels (Fig. 4a). In some cases, the out-of-plane failure of the masonry infills has been observed. This failure mode is mainly related to the out-of-plane inter-storey drift and accelerations that caused the disconnection of the infill panels with the upper beams. At the same time, the in-plane crashing of the infill walls also increased the probability of out-of-plane failure due to the reduced resistance of the panels.

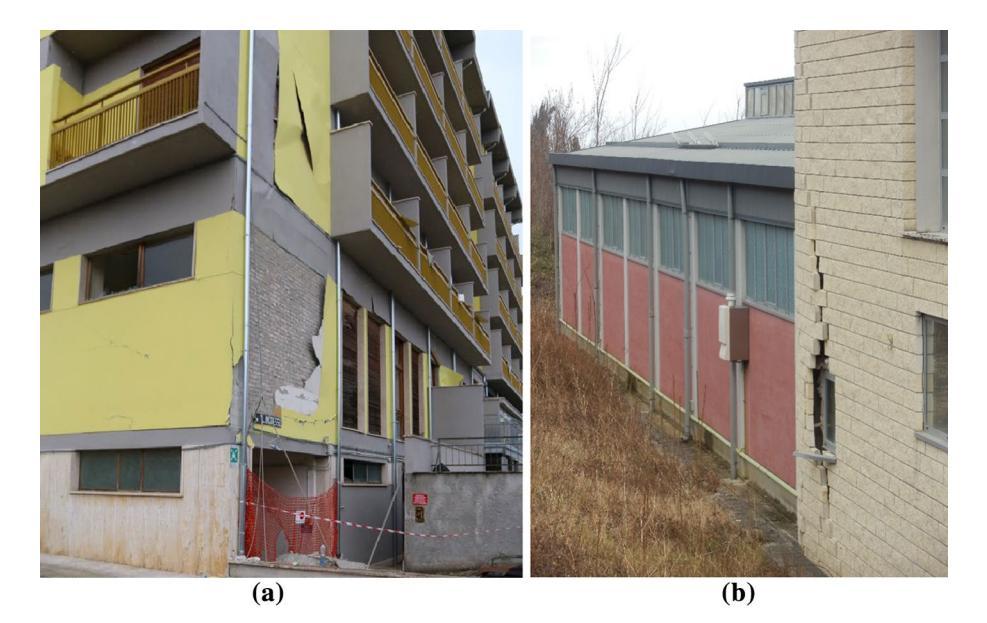
The high deformation of the infill panels often induced the detachment of the external plaster or damage to the cladding (see Fig. 5). The damage of cladding panels is due to the combination of in-plane and out-of-plane accelerations and it is the result of poor connections with the infill panels or with the structural elements (Fig. 5b). The detachment of the plaster was often observed because this element, generally produced with cement, is very fragile and has no reinforcement to provide any strength (Fig. 5a). This kind of damage often represents a serious life threat because of the possible fall on people walking close to the building.

Fig. 5 Typical damage in plaster and cladding. a Damage to plaster in residential building, b damage to cladding in industrial building

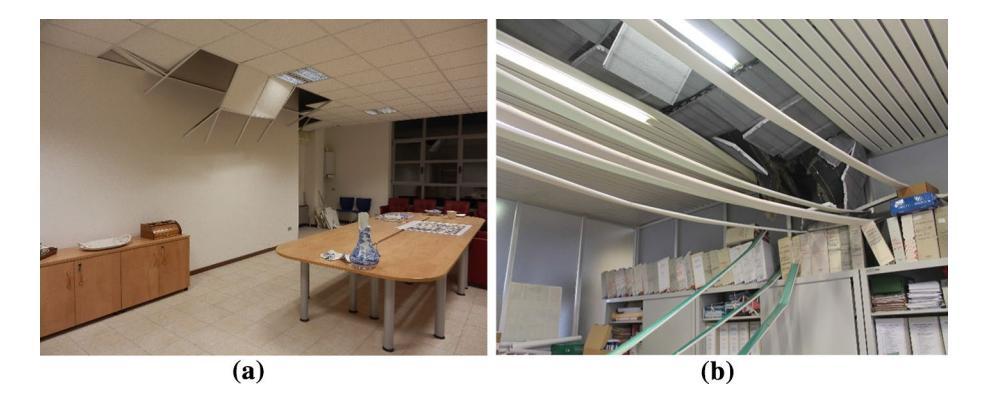
Fig. 6 Typical damage to light ceiling systems. a Acoustical suspended ceiling, b light metallic ceiling system

The most commonly observed damage of the acoustical ceiling systems was: (1) acoustical tiles falling out of the ceiling system (see Fig. 6a), (2) failure of rivet connections at the perimeter fixings (Fig. 6b), and (3) breaking or buckling of the grid members due to induced compressive and torsional loads. In addition, the dynamic interaction between the ceilings and other suspended elements, such as light fixtures, often appeared as a source of damage.

In many cases, extensive damage was concentrated along the ceiling perimeter. This was possibly due to poor detailing or lack of rivets, which caused the loosening of the boundary supports and the consequent collapse of the grid members. Also, the absence of adequate hanger wires caused spreading of the tees and, in turn, the collapse of the tiles. The observation of these damages demonstrated the importance of providing adequate anchorage in particular to the perimeter tiles as their collapse could induce loss of the stabilizing action and hence a subsequent progressive collapse of the whole ceiling system (Badillo-Almaraz et al. 2006). The observed perimeter issues could be overcome

by implementing the recommendations present in international guidelines (i.e. FEMA E-74 2012).

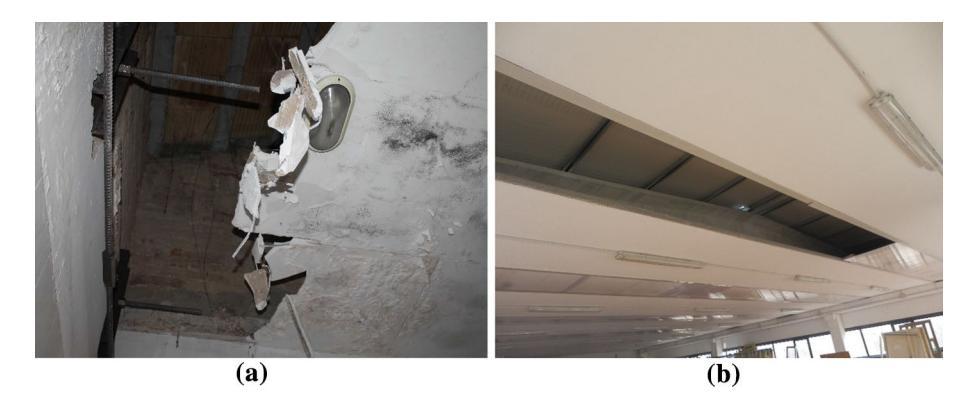
Fig. 7 Typical damage to heavy ceiling systems. a Damage to plasterboard ceiling system, b damage to concrete ceiling system

The observed damage to plasterboard and concrete ceiling systems was mainly attributed to poor connections to the supporting floors (Fig. 7). These systems are heavier than their acoustic ceiling counterparts, and their collapse may have more severe consequences.

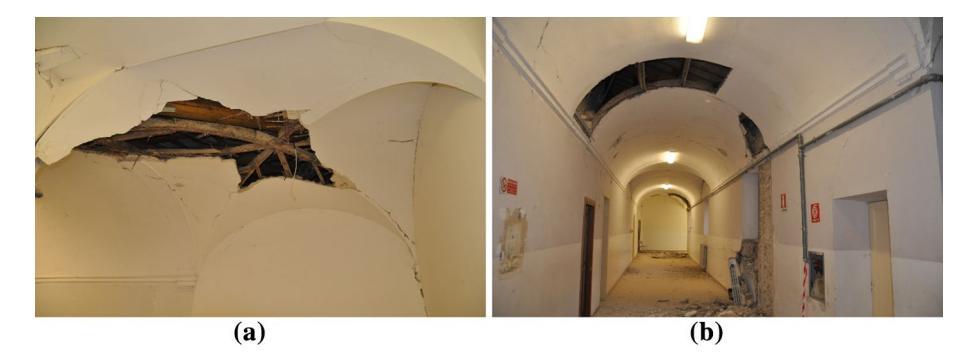
Fig. 9 Typical damage to "camorcanna" vaults. a Damage of a rib vault in a school, b damage to a barrel vault in a hospital

Lightweight non-structural vaults, referred to as "camorcanna" vaults, were found in many historic buildings and presented extensive damage. 'Camorcanna' vaults are typically composed of reed mats and plaster nailed to an upper wooden framework (Quagliarini et al. 2012). The wooden supporting system is connected to the main structure using wood beams in the two main perpendicular directions. The vaults are often suspended by metallic ties to the upper bearing structures and, in many cases, springs are used to mitigate the vertical vibrations (Fig. 8). Frescoes and stuccoes of artistic and historical value were often observed on the lower surface of these vaults. Typical damage to "camorcanna" vaults is shown in Fig. 9. These vaults were designed and built prior to the development of any seismic design criteria, therefore the somewhat observed poor performance is not surprising. Damage was generally related to the collapse of the plaster along with the reeds, while the supporting wooden framework was generally still in place. The damage to these vaults may represent a significant financial loss, and a destruction of cultural heritage.

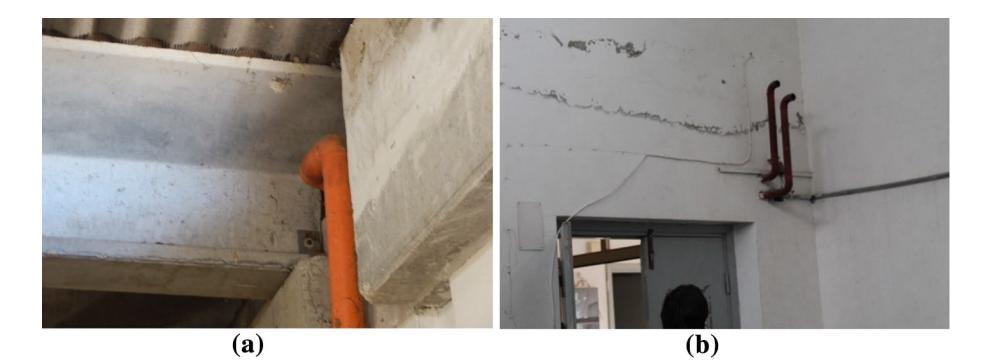
The damage to piping systems observed after the 2016 Central Italy earthquake was mainly related to the failure of the piping joints (Fig. 10). Figure 10 shows two pipelines, made of different materials, in which the failure of the piping joints caused the collapse of the connected pipes that were not braced. At the date of the inspections, the failed pipes were already removed. For this reason it was only possible to see the interrupted pipelines. As reported in previous experimental studies (Tian et al. 2014), the piping joints are the weakest link in the piping systems, particularly in absence of bracing intended

Fig. 10 Typical damage in piping systems. a Failure of PVC piping joint, b failure of steel joint

to accommodate the earthquake induced demands. It is also important to note that the observed damage is generally close to the change of direction in the piping systems. This observation confirms the effectiveness of the requirements suggested by some guidelines (NFPA13 2010; FEMA E-74 2012) to reduce the spacing between the lateral supporting systems in the proximity of the change of direction in the piping systems.

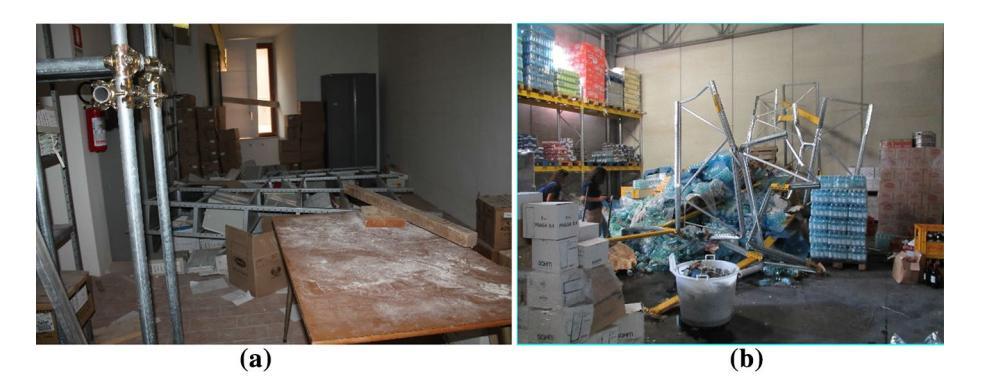
Fig. 11 Typical damage in storage racks. a Overturning of shelves in a school building, b collapse of a storage rack in an industrial building

Extensive damage to shelves and racks was observed following the 2016 Central Italy earthquake, as shown in Fig. 11. The observed damage to shelves and storage racks was mainly associated with overturning issues or with the buckling of the vertical uprights. This type of damage can typically be prevented by anchoring the shelving units to the adjacent walls, and by providing some connections between parallel units. Figure 12 shows examples of properly anchored shelves in a hospital building observed during the post-earthquake inspections for which good seismic performance was observed. The connection of the shelves to the adjacent wall prevented the overturning of the storage unit (Fig. 12a). Unanchored shelves affected by overturning issues were observed in the same building.

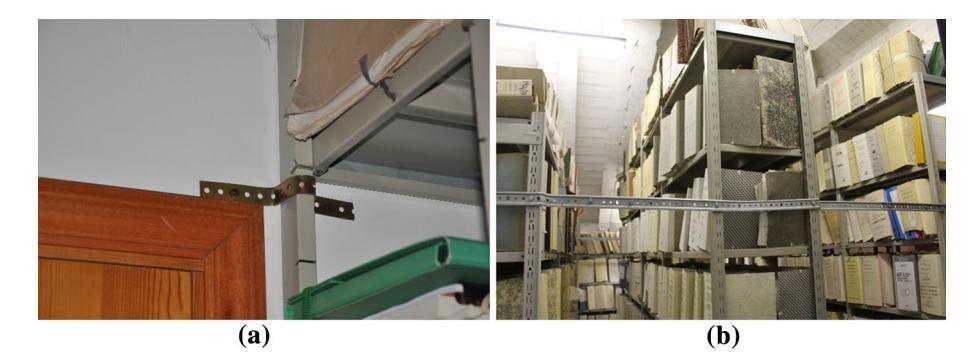
Fig. 12 Examples of mitigation details for shelves. a Attachment to the wall, b connection of parallel shelves

Figure 12b shows an example of a mitigation detail in which parallel shelves have been connected to each other using horizontal steel "channels". This bracing technique prevented damage to the shelves, concentrating damage in the braces. After the earthquake, the original configuration of all units could be restored simply by replacing the horizontal bracing elements.

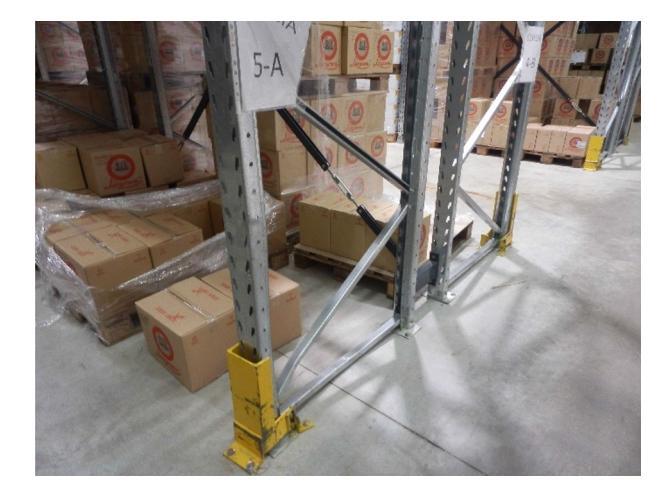
The bracing of heavy storage racks in industrial facilities can limit damage during an earthquake. An example observed during the post-earthquake inspections is provided in Fig. 13: no damage was observed following the earthquake due to the adoption of a bracing system along with a special base connection, that allows relative movement at the floor level.

Fig. 13 Example of seismically designed storage racks

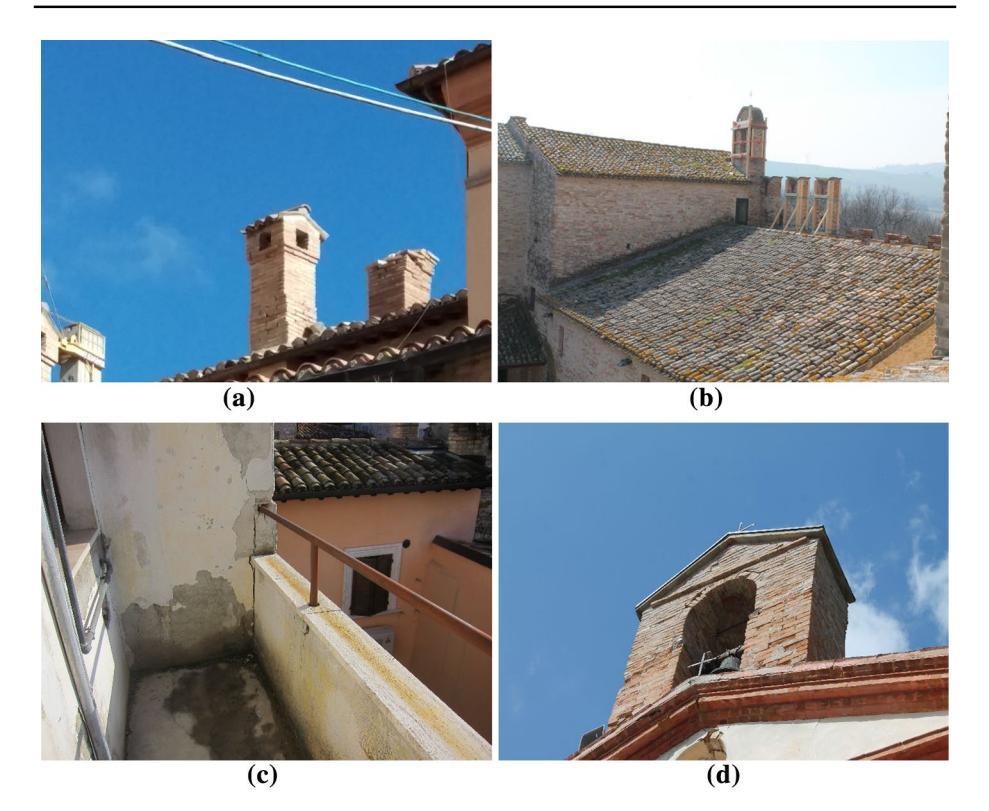
Chimneys, appendages and parapets are very common acceleration-sensitive NSEs. Damage to chimneys and appendices was widespread and extensively documented after the 2016 Central Italy earthquake (Fig. 14a). Unreinforced masonry chimneys were most severely damaged, while chimneys and appendages made of other materials, such as steel, were affected to a lesser extent.

Historic buildings and churches often have slender masonry appendages on their roofs, which are subjected to high earthquake-induced roof accelerations. These accelerations can be recorded at low levels of ground acceleration because of the dynamic filtering and amplification. The observed damage ranged from minor cracking to complete collapse of the elements. Similar behaviour was observed with parapets (Fig. 14c) and bell-gable (Fig. 14d). The performance of chimneys, parapets, and appendages can be significantly improved by adopting simple mitigation interventions (FEMA E-74 2012; DPC 2009). These include providing confinement and installing lateral bracing systems to prevent overturning. Figure 14b shows a temporary post-earthquake propping system with a similar configuration to the mitigation details provided by FEMA E-74 (2012). The effectiveness of these simple mitigation measures was demonstrated during the subsequent shocks that struck Central Italy in October 2016.

Fig. 14 Typical damage to masonry appendices. a Damage to chimney, b damage to appendices, c damage to parapets, d damage to bell-gable

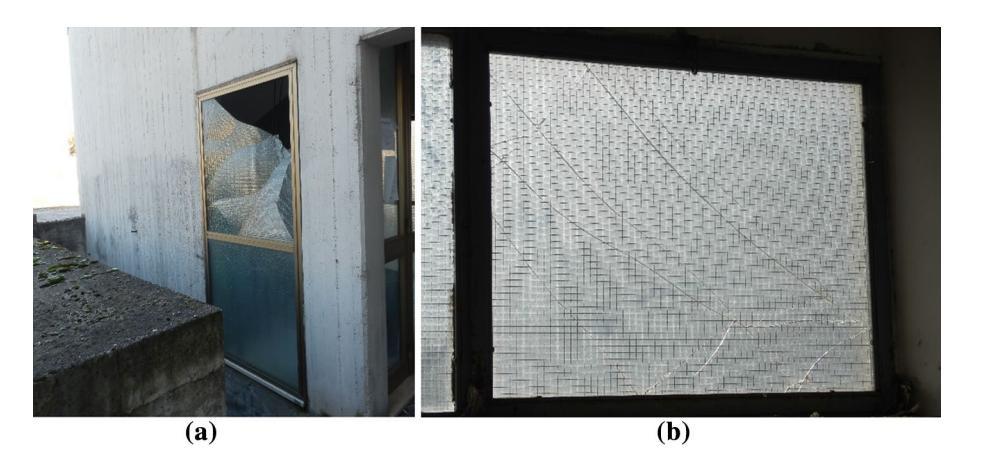
Fig. 15 Typical damage to glazing systems. a Damage to door, b damage to windows

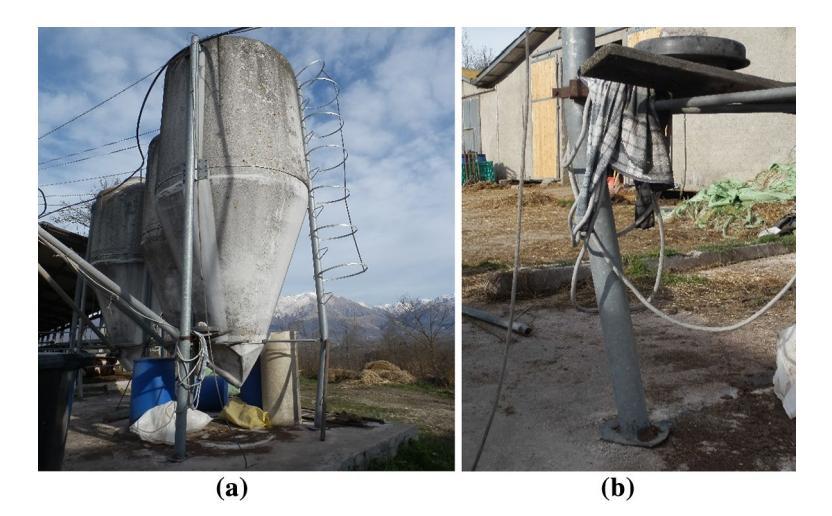
Damage to tanks and mechanical equipment can severely limit the functionality of facilities after an earthquake. Damage to tanks was observed in a number of agricultural and breeding facilities. A damaged steel fodder storage tank is shown in Fig. 16. The excessive axial loads resulting from the overturning moment induced by the earthquake inertial forces caused buckling of the tank steel legs. Failure of the connections between the tank legs and the concrete deck was also observed due to the deformation of the steel flanges. These failure modes could have been prevented by providing a bracing system and more robust base connections (FEMA E-74 2012).

In some cases, damage to mechanical equipment anchored to concrete floors was observed. In these cases, the poor performance was attributed to the inadequate base

Fig. 16 Typical damage to steel tank. a Steel tank, b base connection

connections, which typically consist of springs intended to mitigate non-seismic vibrations. The vulnerability of mechanical equipment can be partially reduced by positioning elastomeric snubbers alongside the vibration isolation coiled springs (Filiatrault and Sullivan 2014).

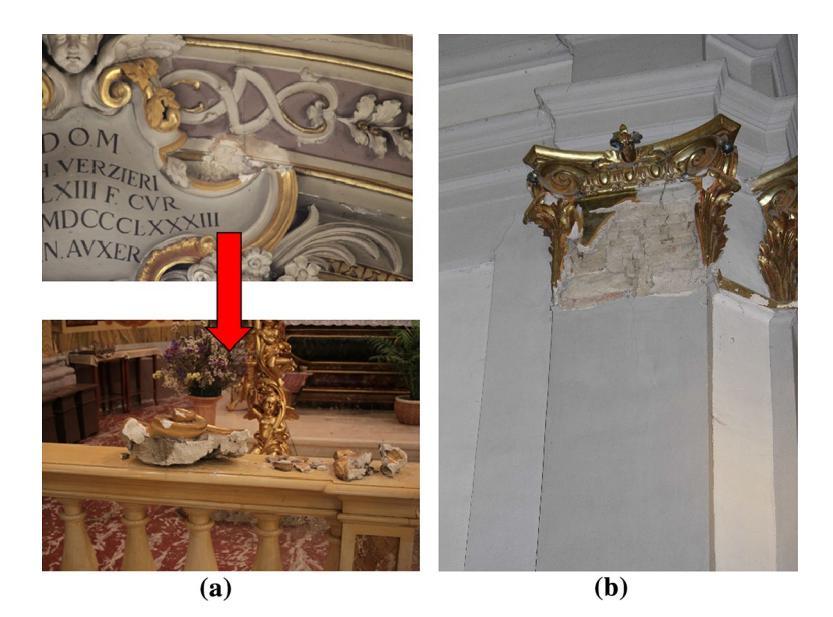
Fig. 17 Typical damage to stuccoes and decoration. a Stuccoes, b capital

palaces to stuccoes and decorations (Fig. 17). In most cases damage was limited to cracks, but in many cases there was enough movement to cause the detachment of the stuccoes and frescoes. The observed damage is related to the earthquake-induced vibrations and the deformation of the main structures. The stuccoes are generally made with cement plaster and gesso, these materials are very stiff and have no reinforcement to provide any strength, for this reason the cracking of the supporting structures often caused their detachment. The stucco reported in Fig. 17a detached from a triumphal arch in a church and its weight was approximately equal to 9 kg; the collapse of this heavy element posed a serious threat to the safety of the occupants.

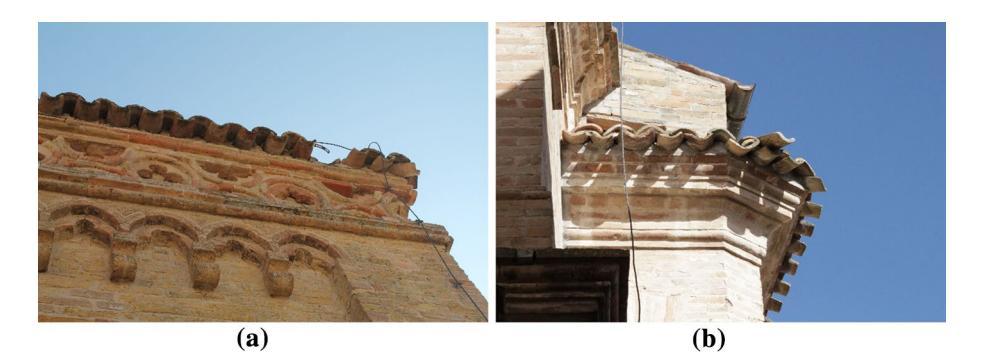
A large number of buildings in Central Italy has roofs with tiles. The tiles are generally not anchored to the roofs and even low levels of ground acceleration can cause them to displace from their original position. One of the most common damage and hazard for passers-by was related to roof tiles falling off the roof, see Fig. 18.

Fig. 18 Typical damage to roof coating. a Downfall of roof tiles, b roof tiles disconnected from the supporting system
