Seismic performance of non-structural elements during the 2016 Central Italy earthquake

D. Perrone¹ · P. M. Calvi² · R. Nascimbene³ · E. C. Fischer⁴ · G. Magliulo⁵

Keywords Non-structural elements · Central Italy earthquake · Post earthquake reconnaissance

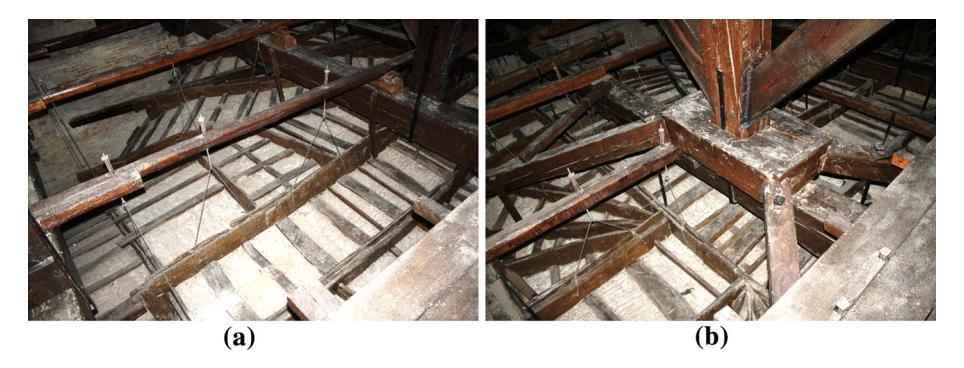
Fig. 8 Connection of the "camorcanna" vaults to the floor. a Vertical supports, b supporting wood structure

systems typically have finish material attached to a two-way grid which is suspended from the above. Finally, light vaults suspended by wooden or metallic ties to the upper bearing structures were observed mainly in heritage buildings (Figs. 8, 9); these vaults are constructed out of wooden arches, reeds, and plaster.

Lightweight non-structural vaults, referred to as "camorcanna" vaults, were found in many historic buildings and presented extensive damage. 'Camorcanna' vaults are typically composed of reed mats and plaster nailed to an upper wooden framework (Quagliarini et al. 2012). The wooden supporting system is connected to the main structure using wood beams in the two main perpendicular directions. The vaults are often suspended by metallic ties to the upper bearing structures and, in many cases, springs are used to mitigate the vertical vibrations (Fig. 8). Frescoes and stuccoes of artistic and historical value were often observed on the lower surface of these vaults. Typical damage to "camorcanna" vaults is shown in Fig. 9. These vaults were designed and built prior to the development of any seismic design criteria, therefore the somewhat observed poor performance is not surprising. Damage was generally related to the collapse of the plaster along with the reeds, while the supporting wooden framework was generally still in place. The damage to these vaults may represent a significant financial loss, and a destruction of cultural heritage.
