Seismic performance of precast industrial facilities following major earthquakes in the Italian territory

On the basis of detailed field observations on a relevant number of buildings, collected just after the earthquakes, seven representative industrial facilities are examined to outline the main vulnerabilities of one-storey precast concrete structures not designed and detailed for seismic loads.

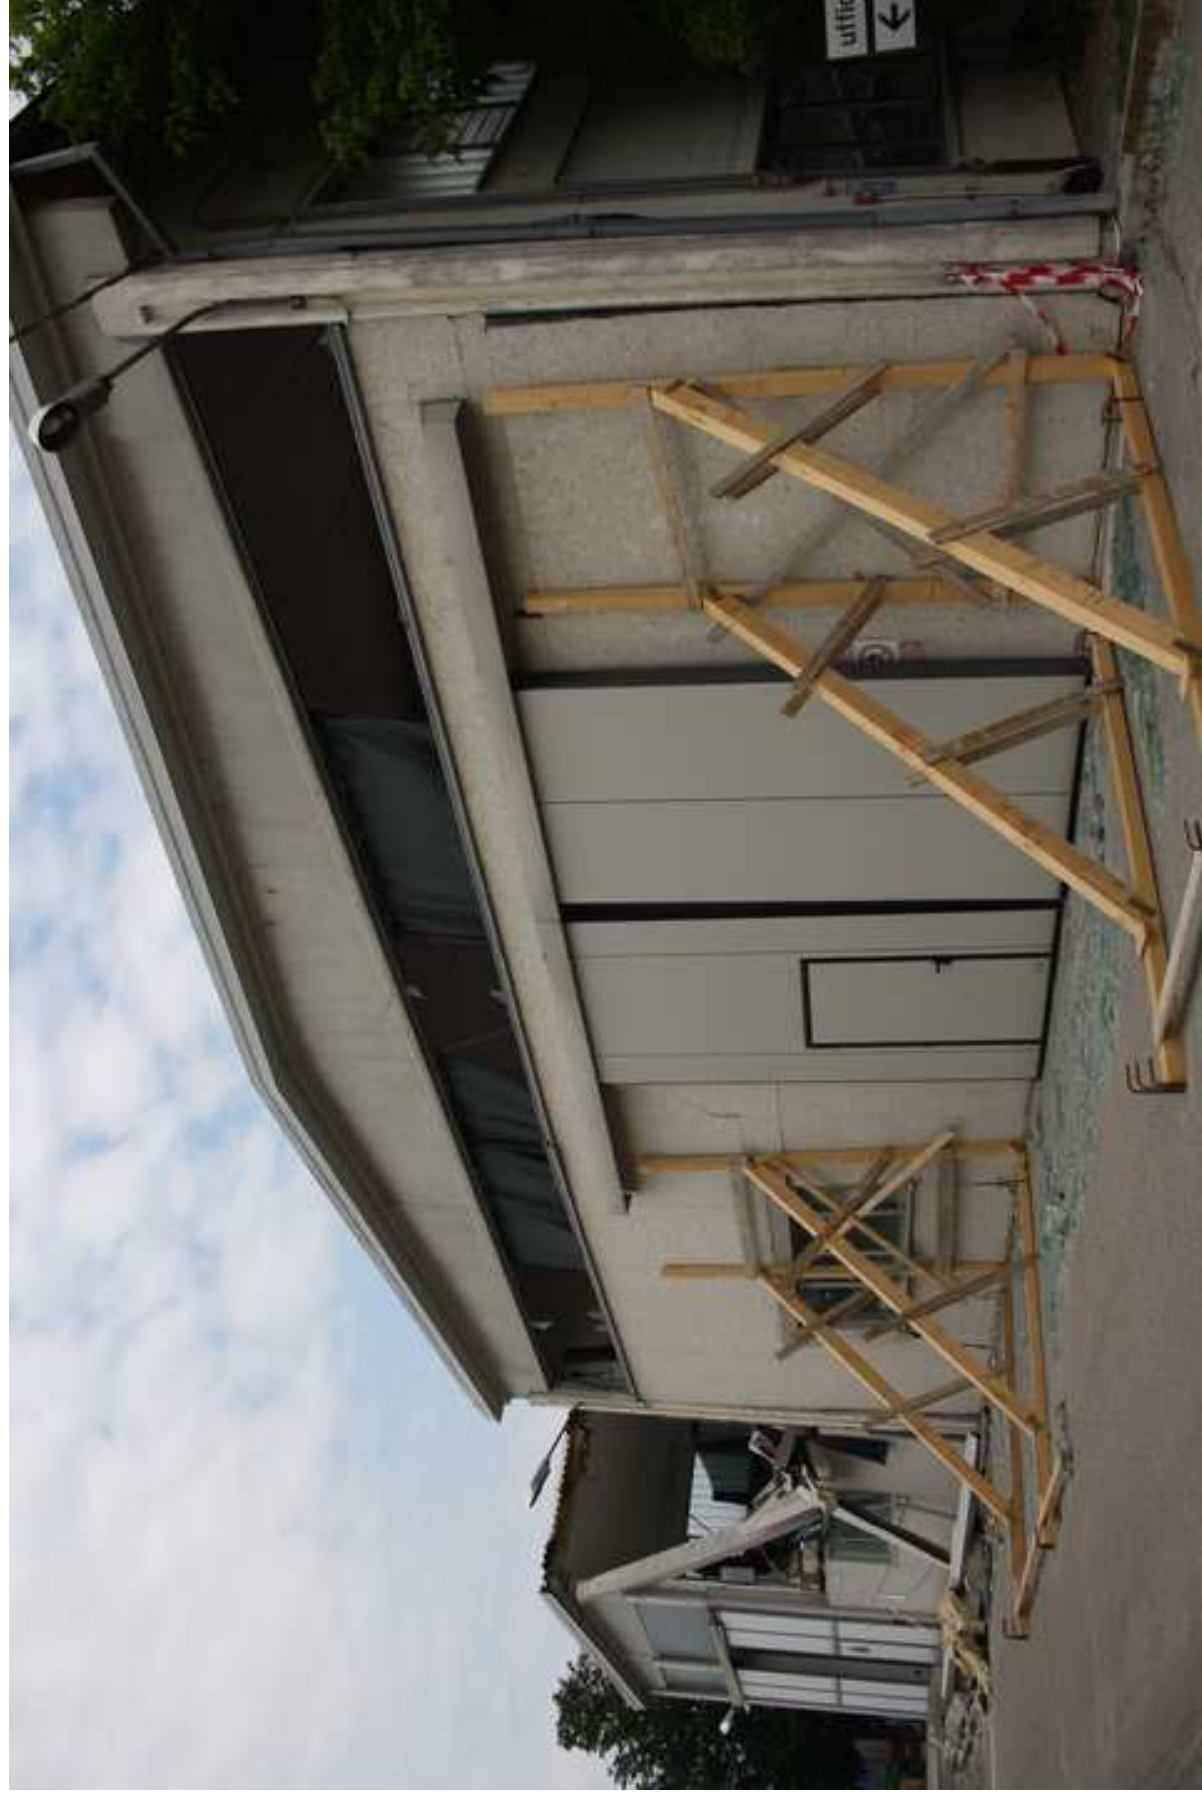
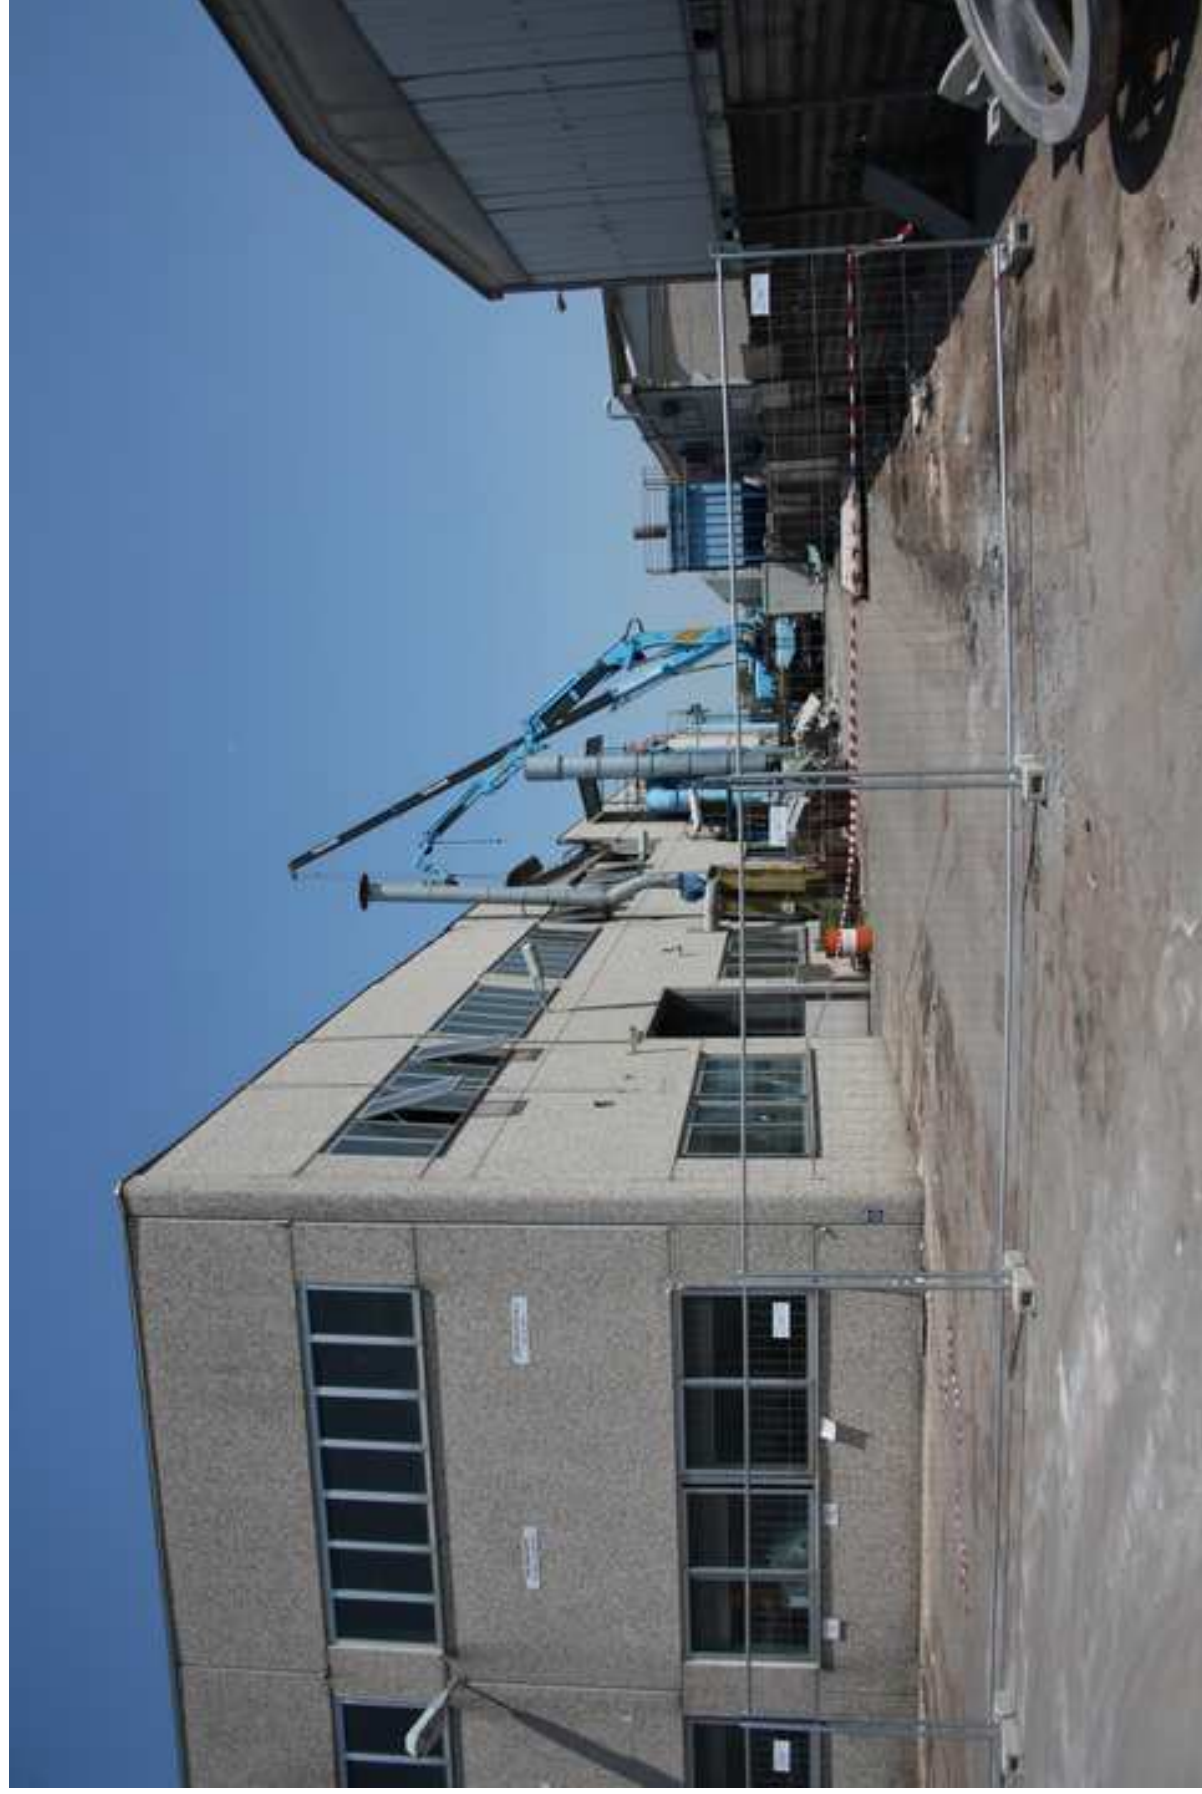
Figure 4a

Examples of the two structural typologies (category A and B) are shown in Fig. 4a and 4b respectively.

Fig. 4. (a) Example of one-storey precast structure built between the 70's and the 80's; (b) Example of more recent one-storey precast structure with longer spans and precast cladding panels

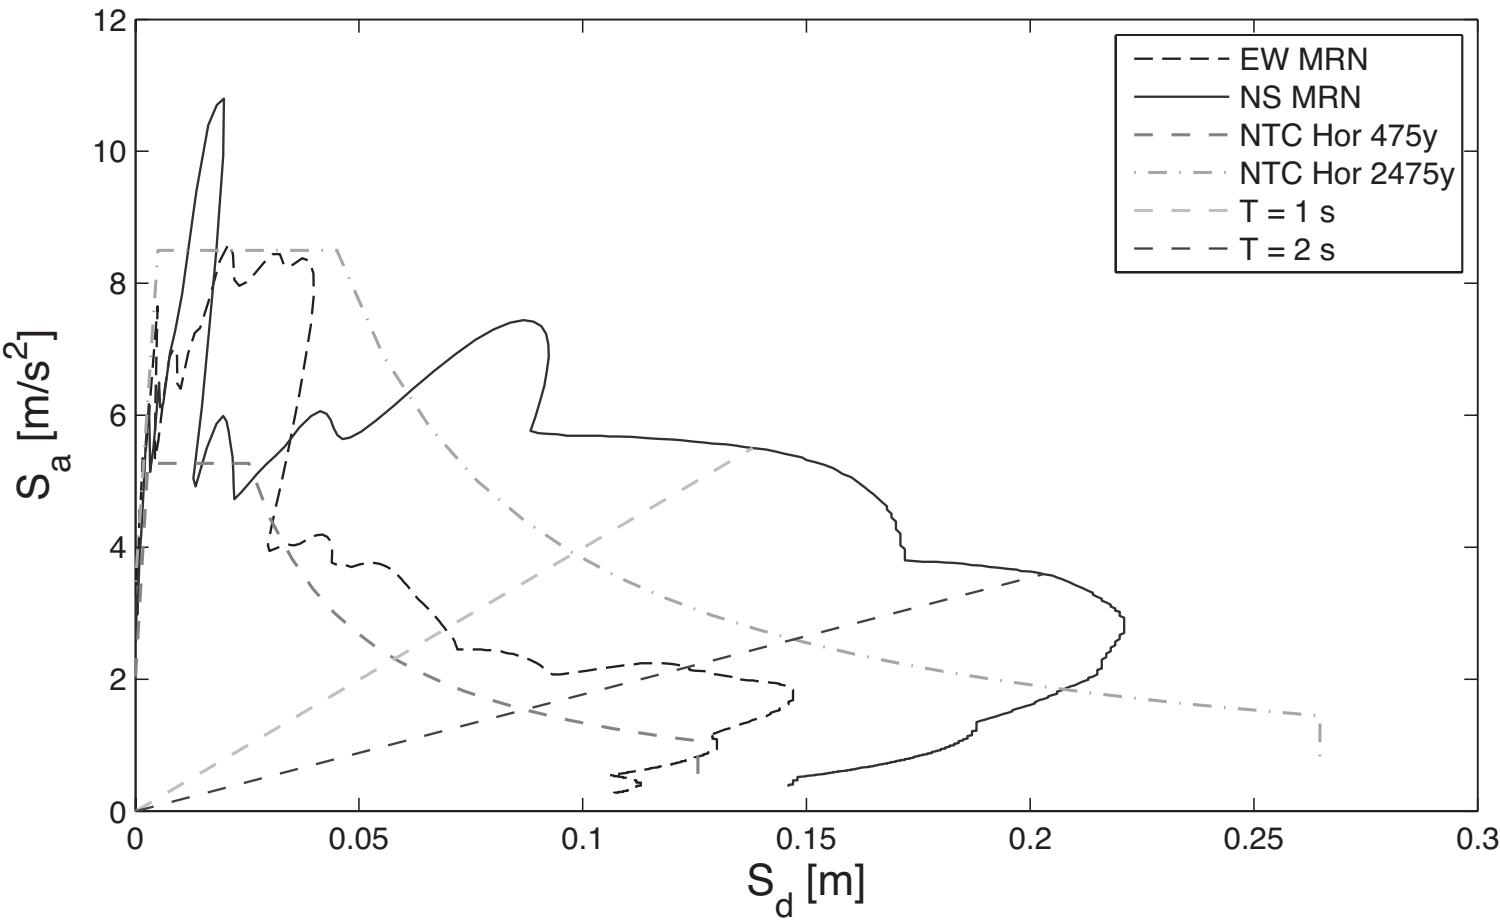
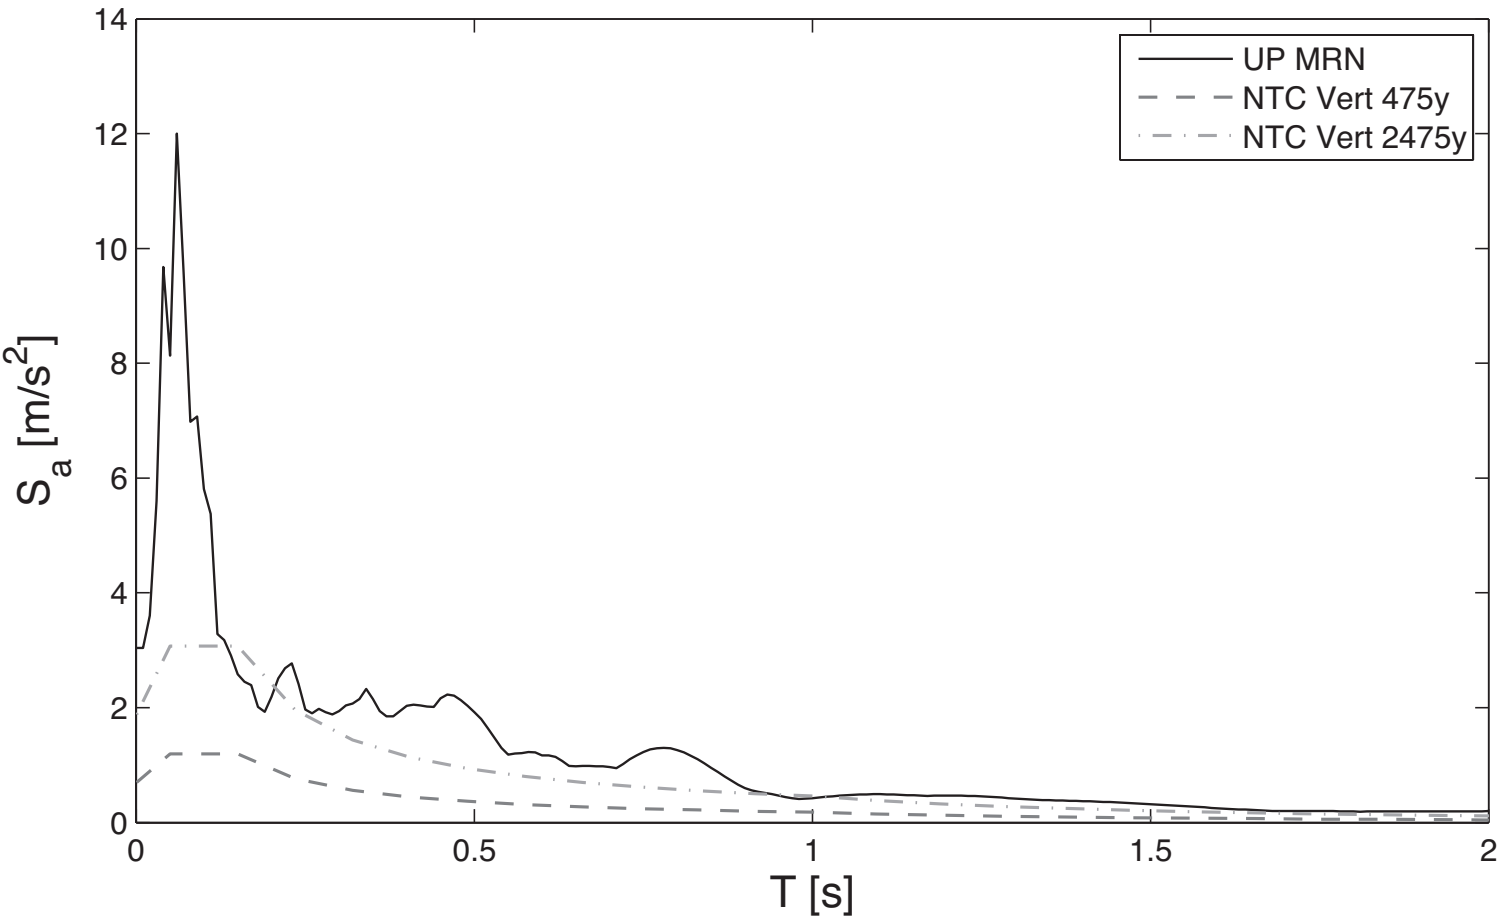
Figure 7a

Qualitative explanation of such collapses, mostly due to the loss of support of the friction based connections, may be searched in the preliminary computations described in the following. Fig. 7(a) shows the elastic ADRS (acceleration displacement response spectrum) graphs (5% relative damping) of the horizontal components, North-South (NS, solid line) and East-West (EW, dashed line), of the May 20th event at Mirandola and the elastic ADRS graphs determined for two return periods, respectively 475 and 2475 years, in accordance with the current Italian Building Code (D.M. 14/01/2008). Fig. 7(b) shows a similar comparison regarding the vertical component. Mirandola, MRN according to the Italian RAN (Rete Accelerometrica Nazionale) network nomenclature, is chosen as it represents the station closest to the epicentre. The accelerograms recorded include site effects according to D.M. 14/01/2008: soil class C ($180 \text{ m/s} < V_s < 360 \text{ m/s}$) and no topographic amplification.

Fig. 7. (a) Elastic ADRS graphs from recorded time histories (NS and EW) and in accordance with the Italian building code (NTC). (b) Elastic pseudo-acceleration response spectra of the vertical component. Note: $\xi = 5\%$

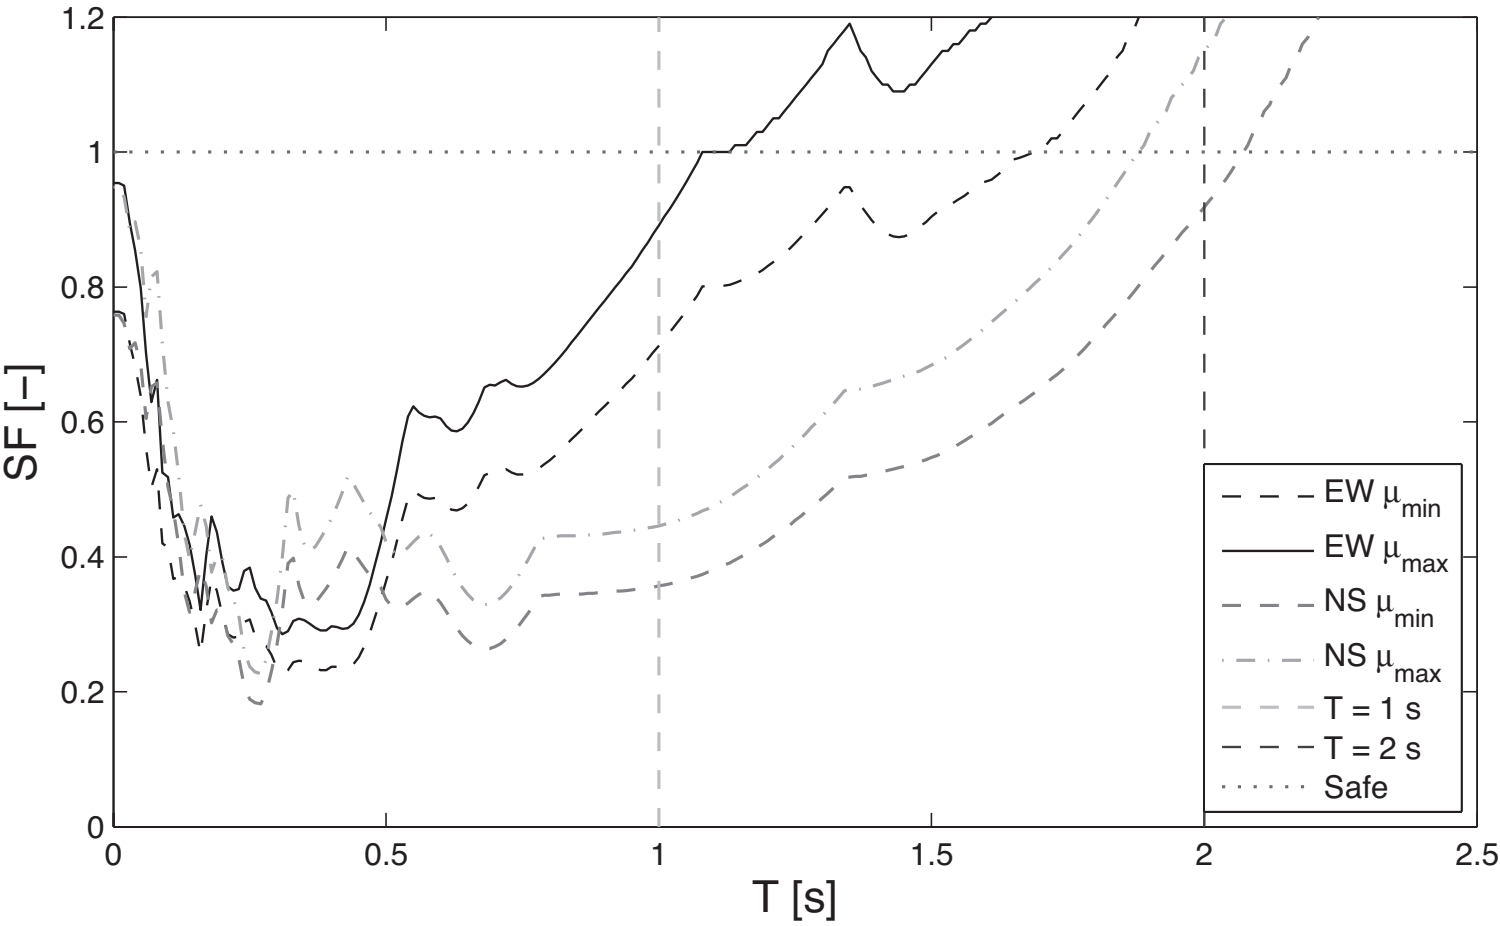
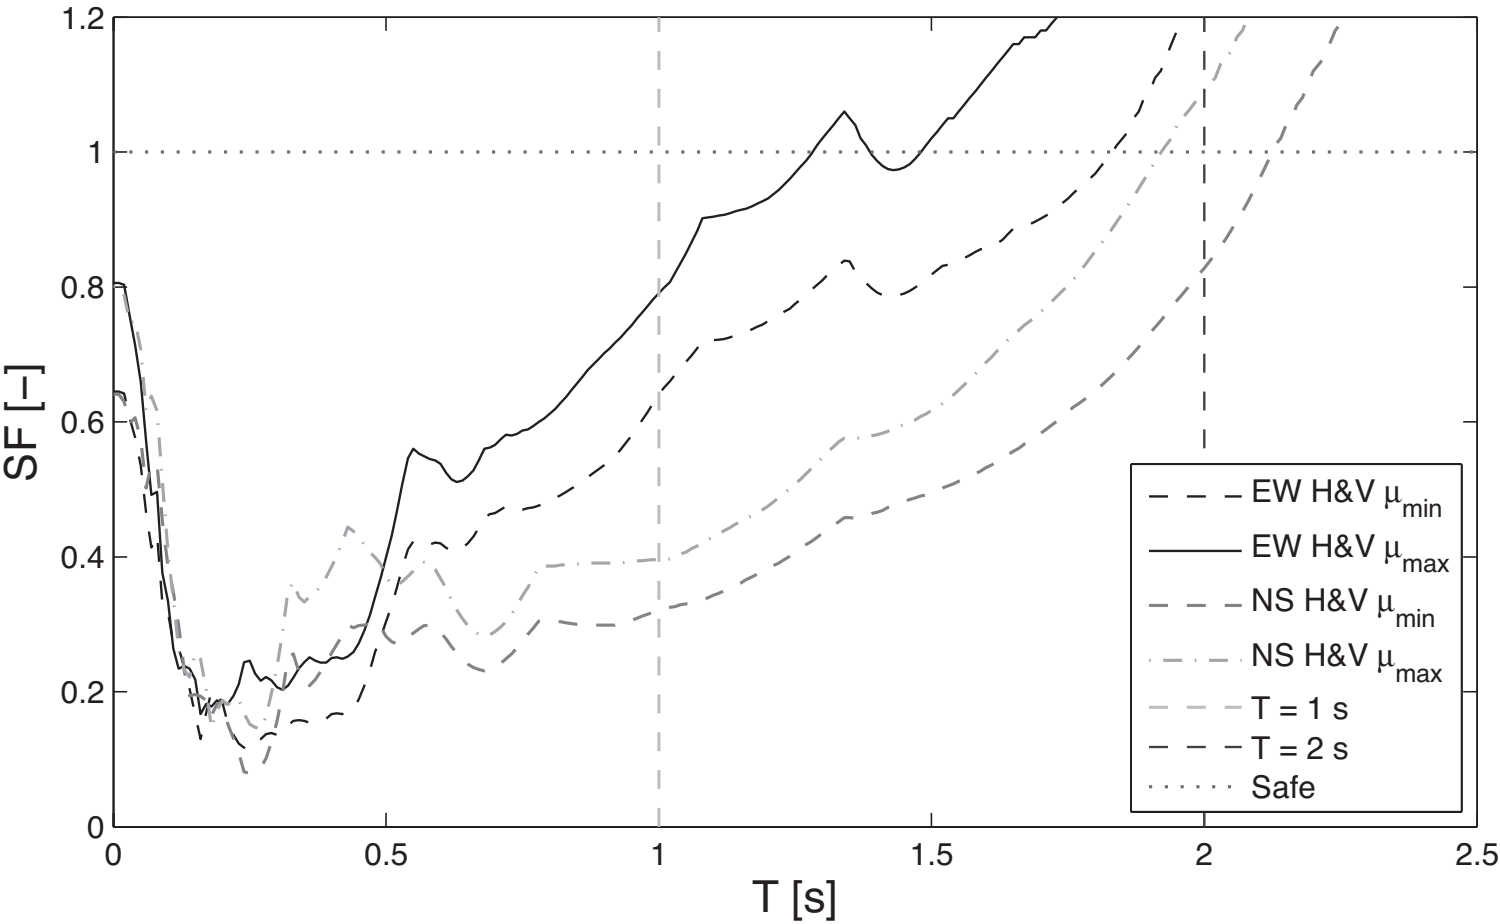
Figure 8a

Fig. 8(a) and (b) present the computed safety factor against the activation of the shear slippage at the beam-to-column connection level, by neglecting and considering the effect of the vertical component ($\pm\Delta N$) respectively. Roughly 10% decay of SF is observed if the vertical component is included, thus confirming the not so prominent effect of the vertical component even though peaks larger than suggested by D.M. 14/01/2008 occurred during the 2012 Emilia seismic sequence.

Fig. 8. Variation of the SF against the activation of the shear slippage at the connection level, (a) by neglecting and (b) considering the effect of the seismic vertical component
