**Italian Joint Reconnaissance Mission**

# Türkiye

**Daily Report**  
**May 10<sup>th</sup> 2023**

## Daily report, May 10th 2023

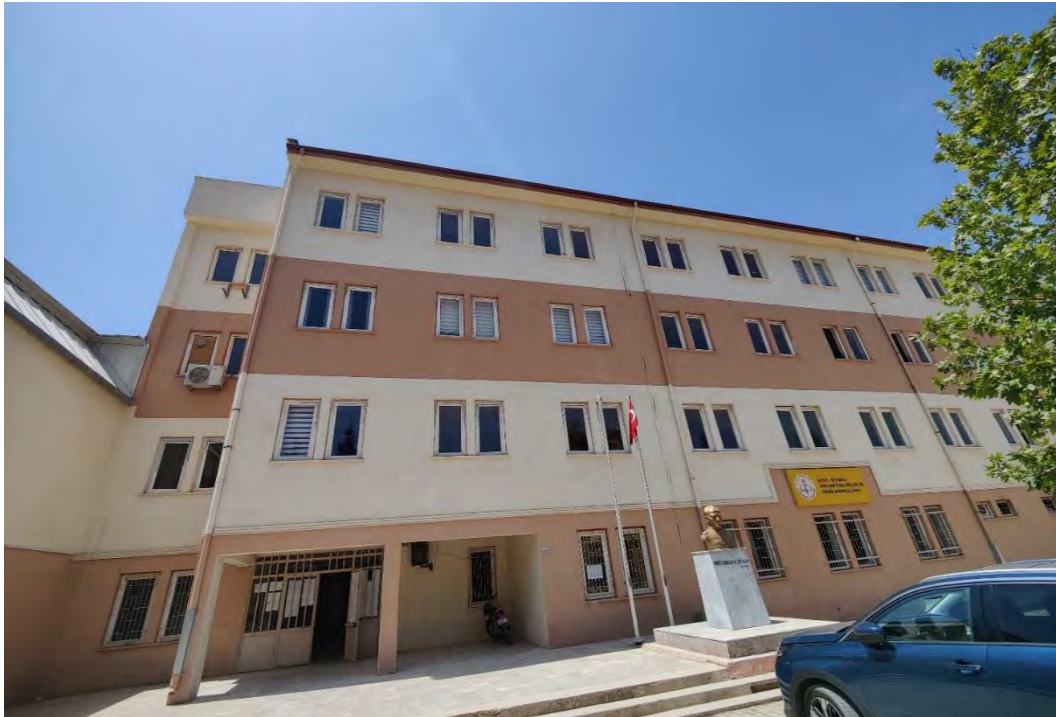
Fig. 4 Front view of the building

This building does not exhibit earthquake damage. All that can be observed is some separation of the masonry infill around the gym area, that was probably caused by some existing case of foundation settlement, as shown in Fig. 5. The building exhibits a strengthening system consisting of RCC shear walls spanning the entire height of the building

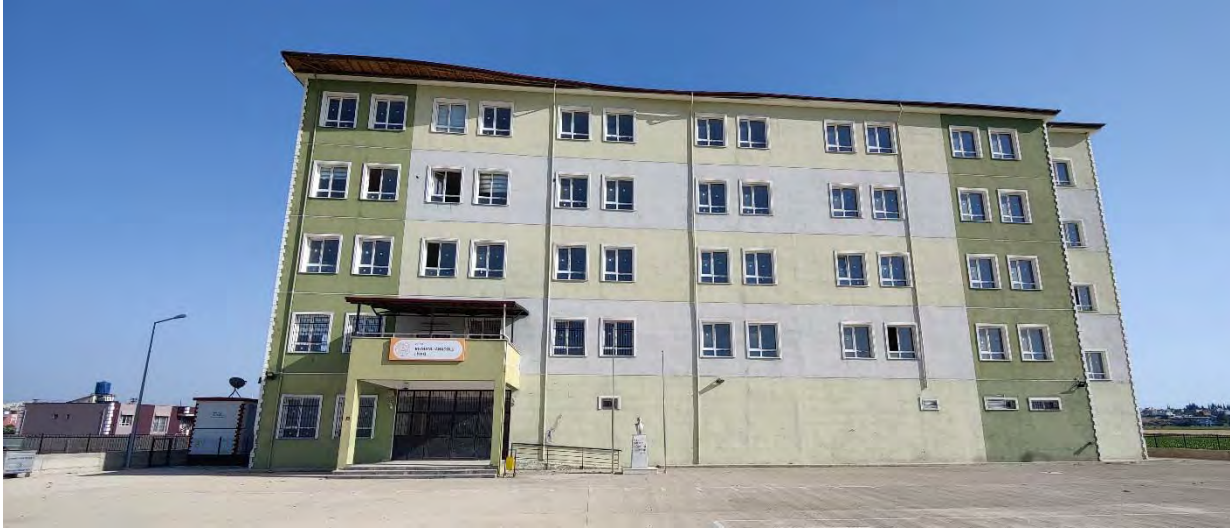
Fig. 6 – Front view of the building.

This building was closed to scholastic activities. It exhibits ubiquitous cracks on all sides, that only seem to concern the finishing mortar. The roof cover has evident damage, with part of it on the front side being displaced with some the roof tiles falling over.
